# Inspection Report

Report Number: 707687

Report #707687

2008 Nissan 350Z

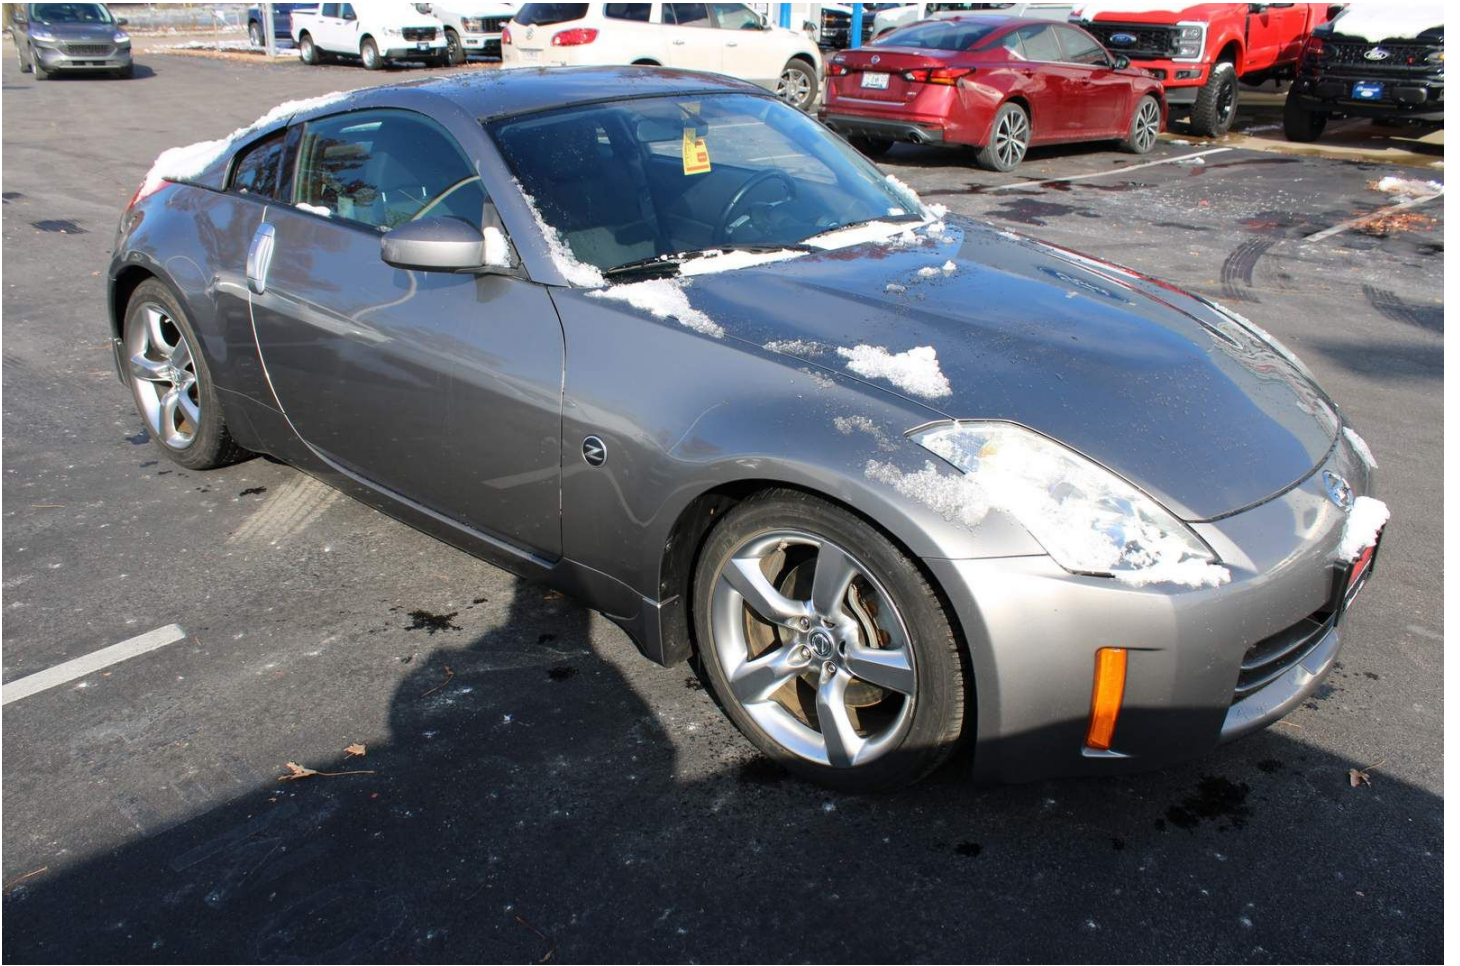
scratch

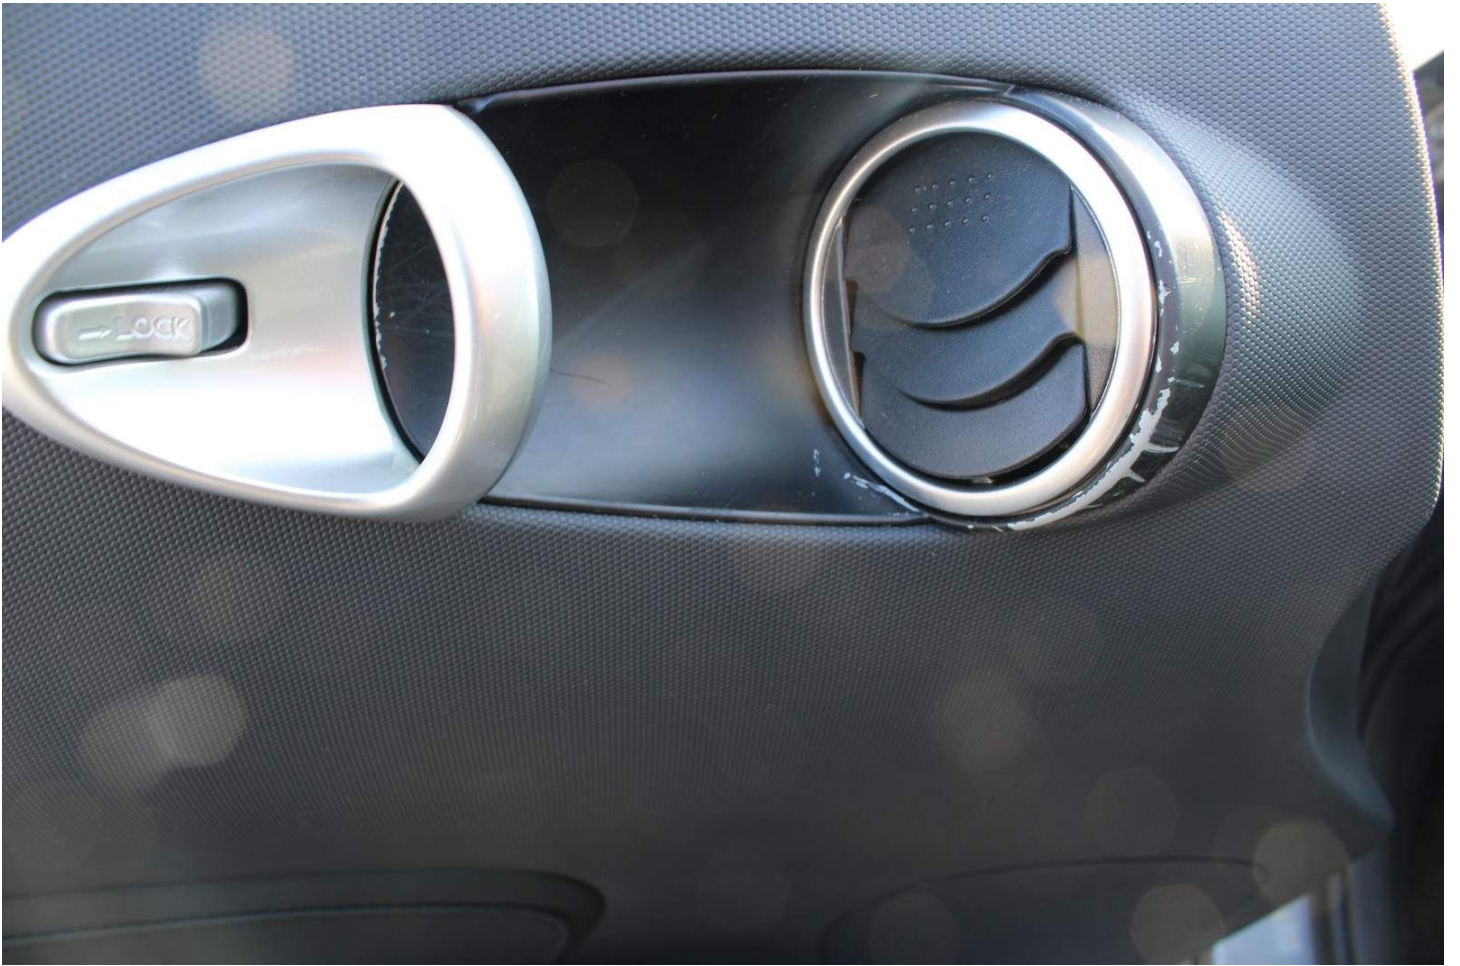
The inner door panels show wear. There are scratches around the inner door handles and vents.

wear and scratches

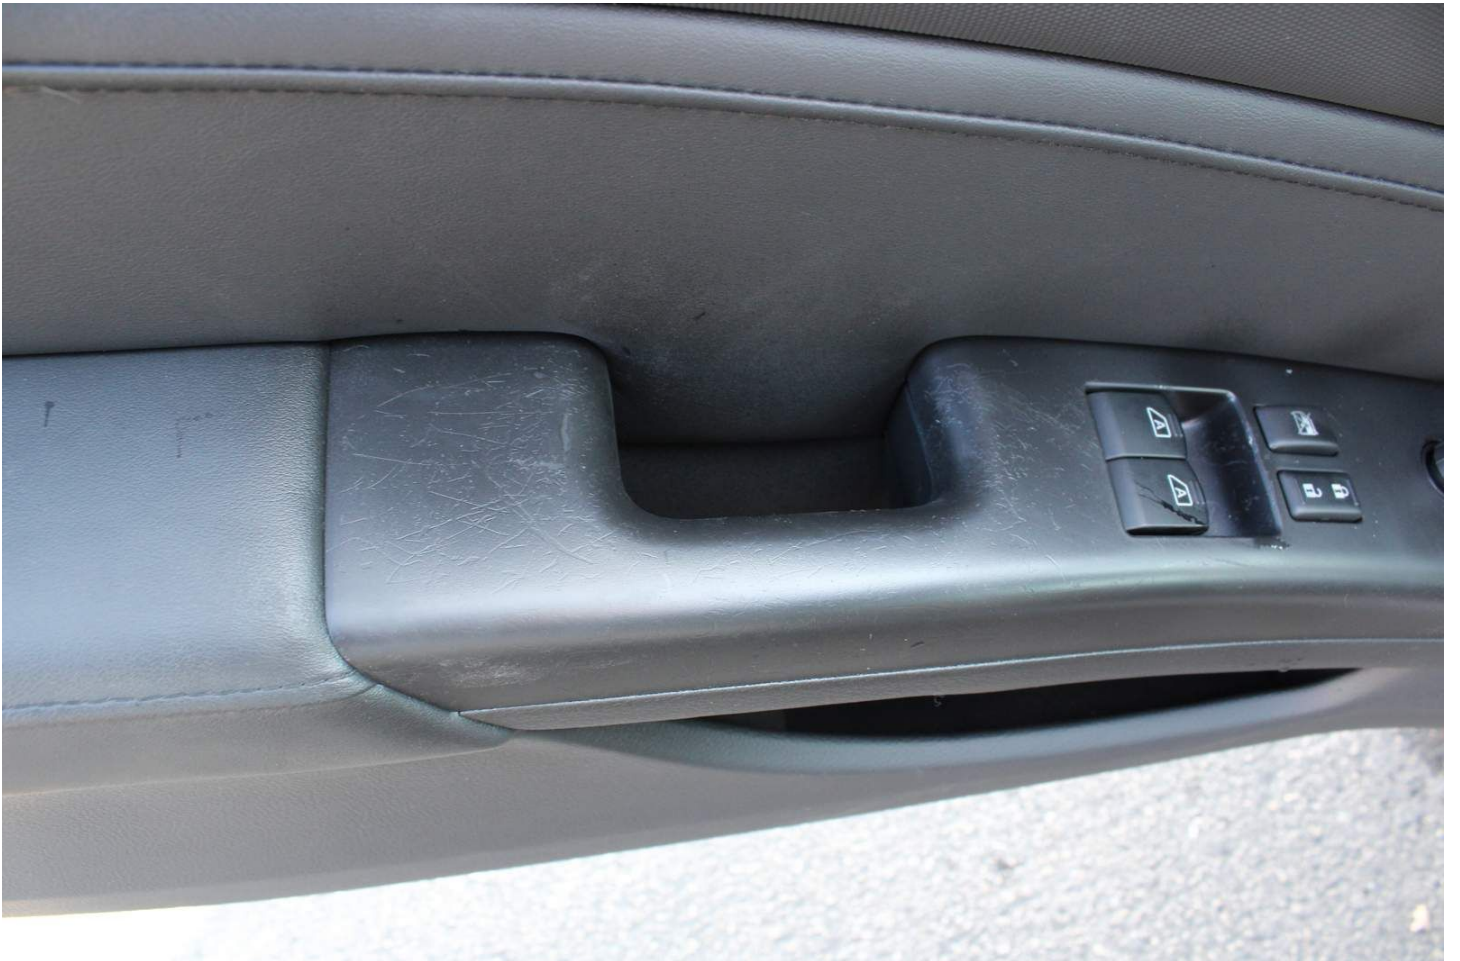
scratches

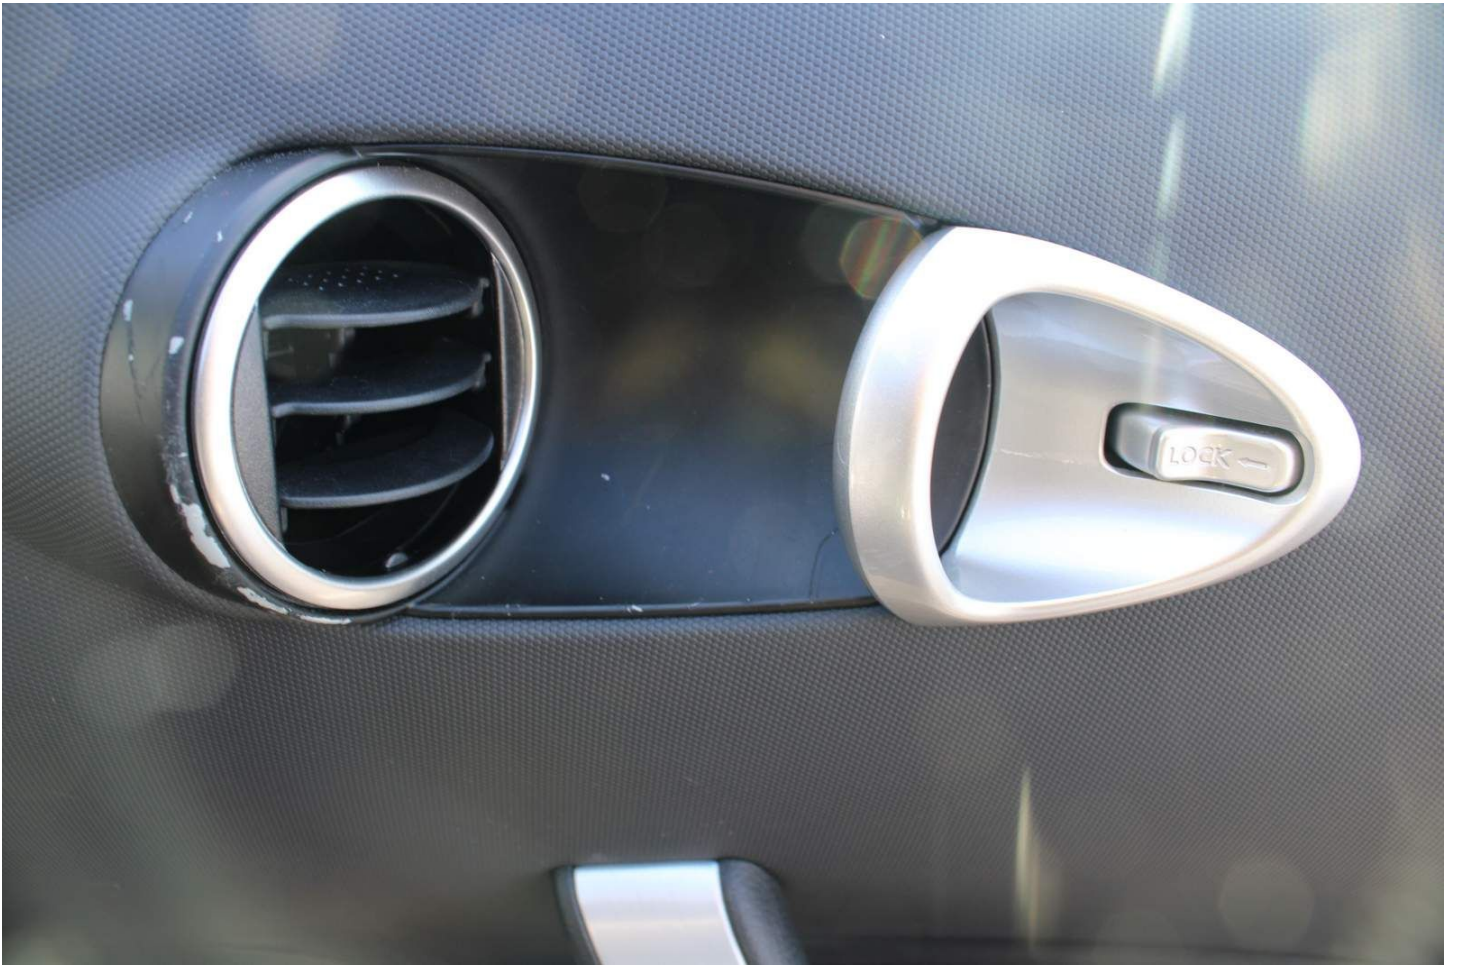
scratches

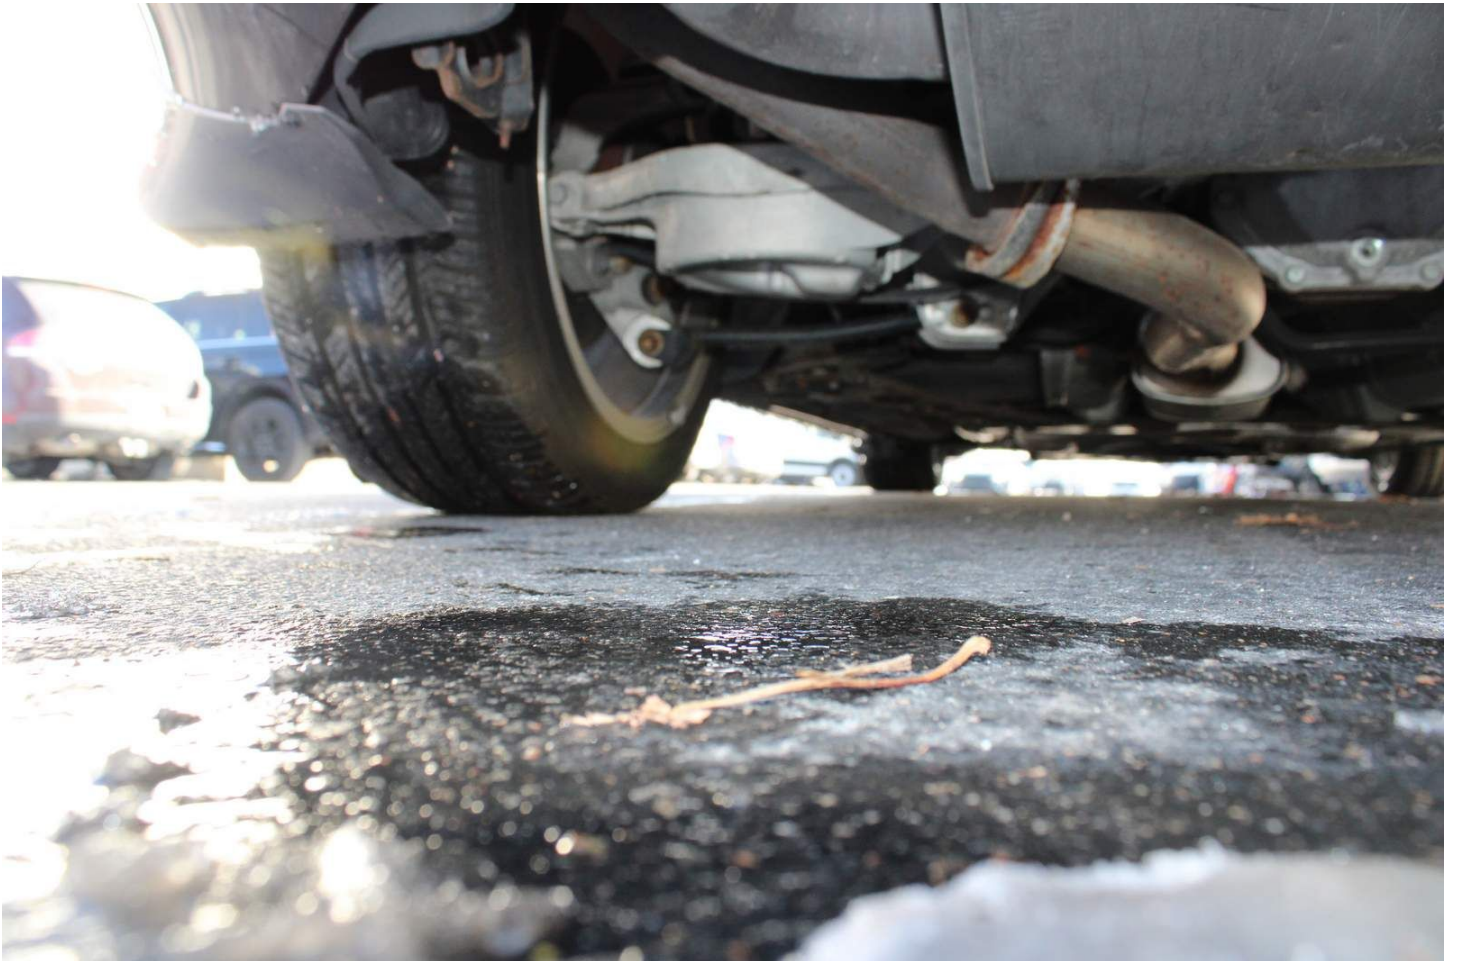
The underside shows areas of surface rust. See pictures.

surface rust

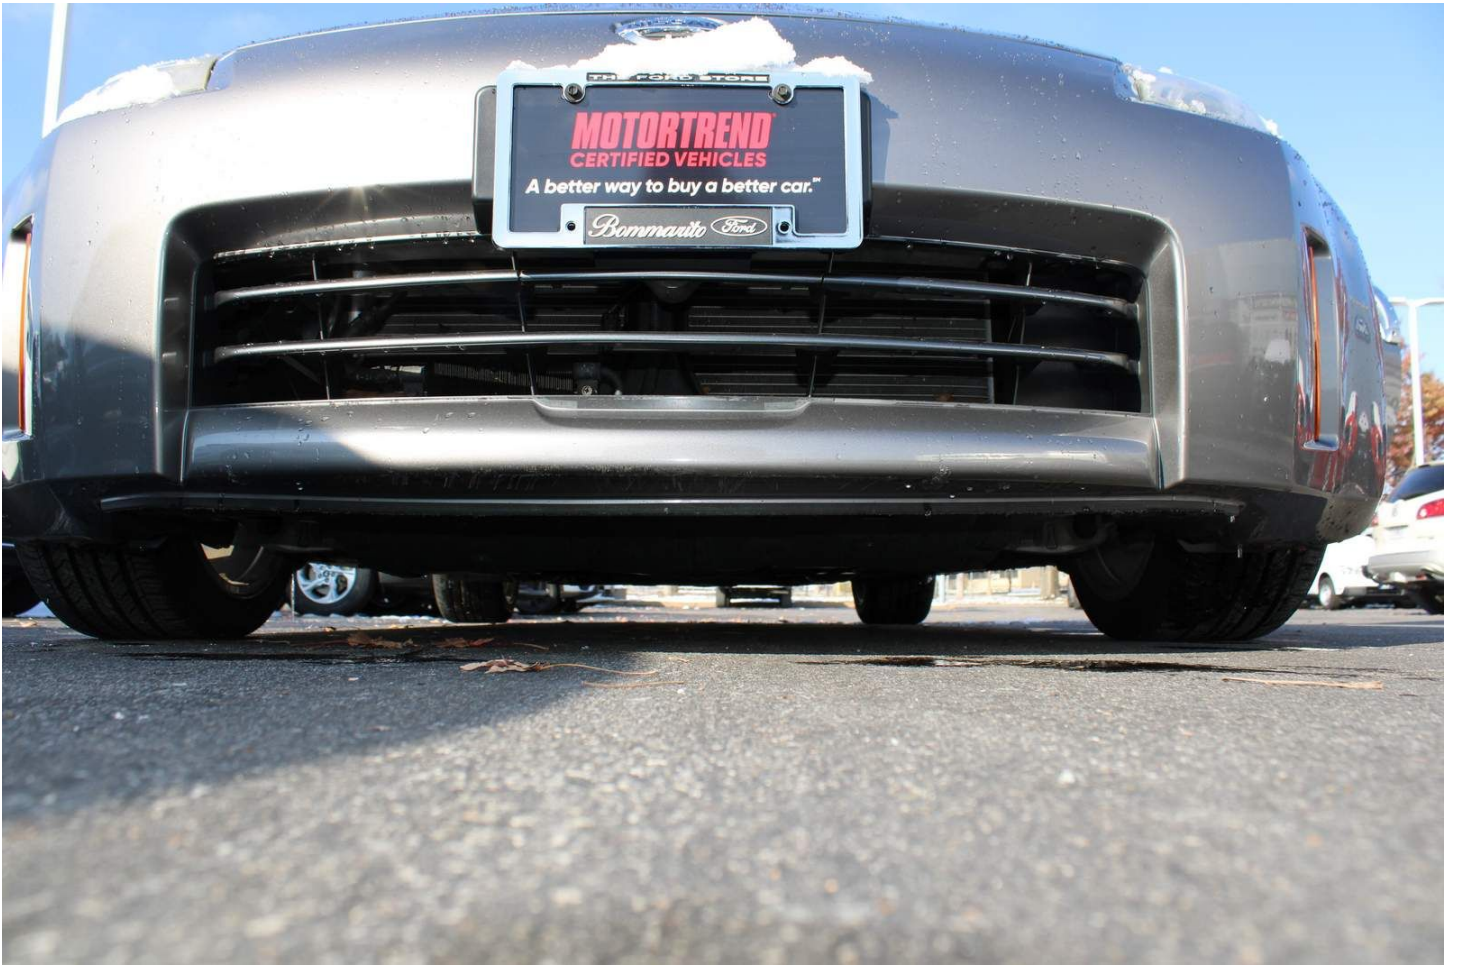
scratches

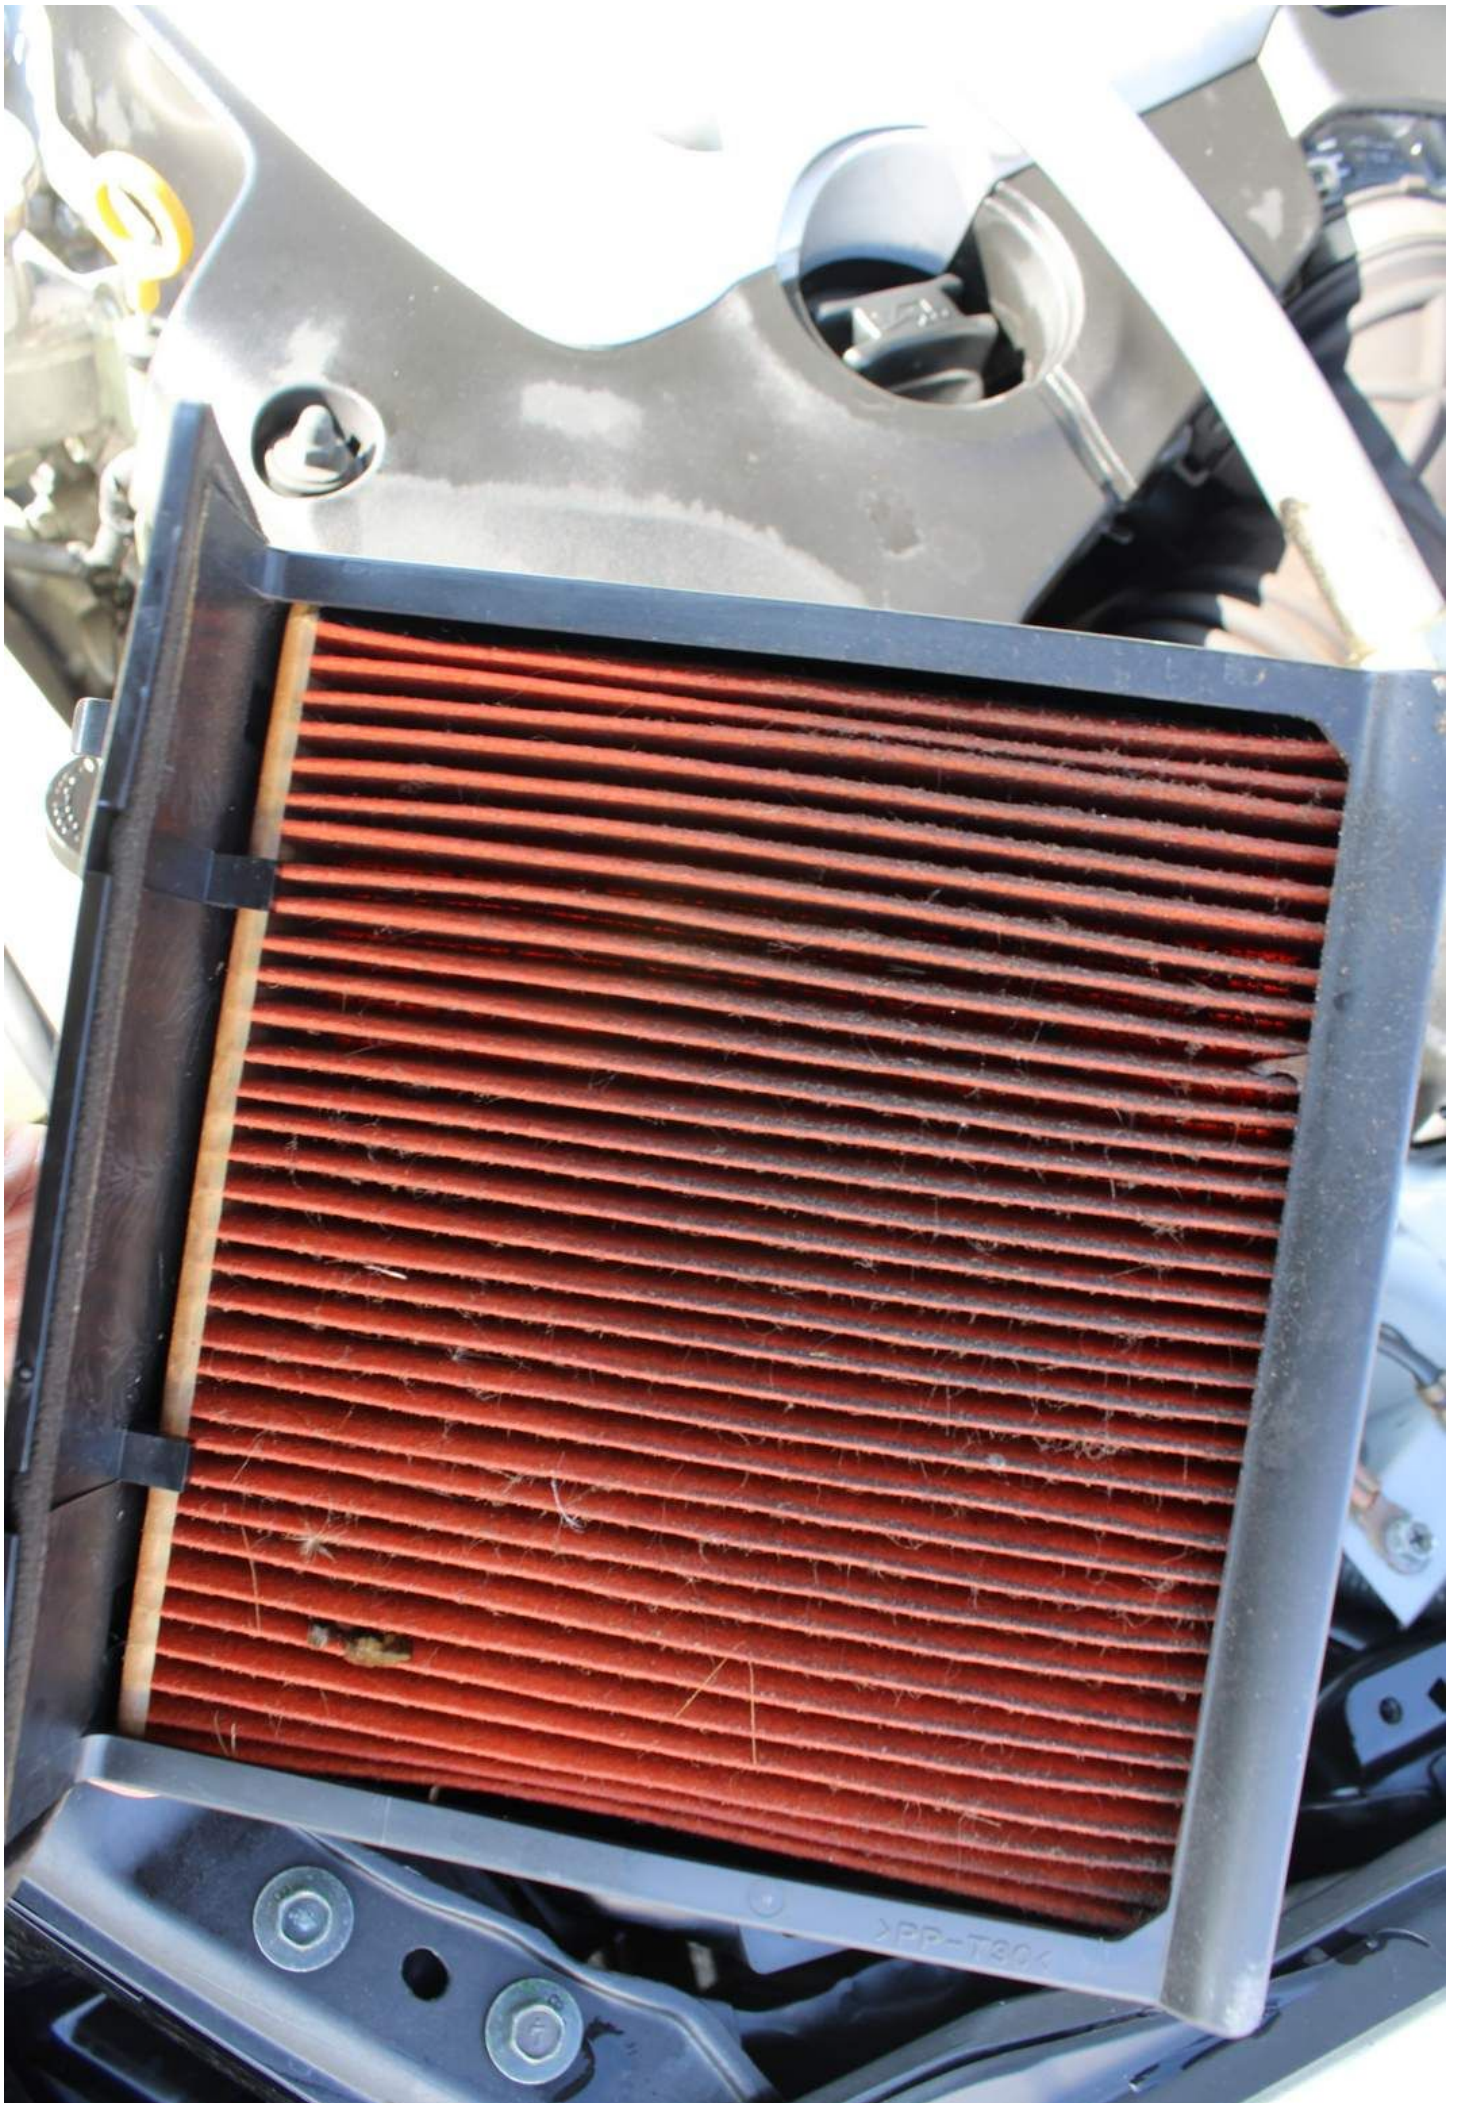
The air filter is dirty and needs to be replaced pic 76.

dirty

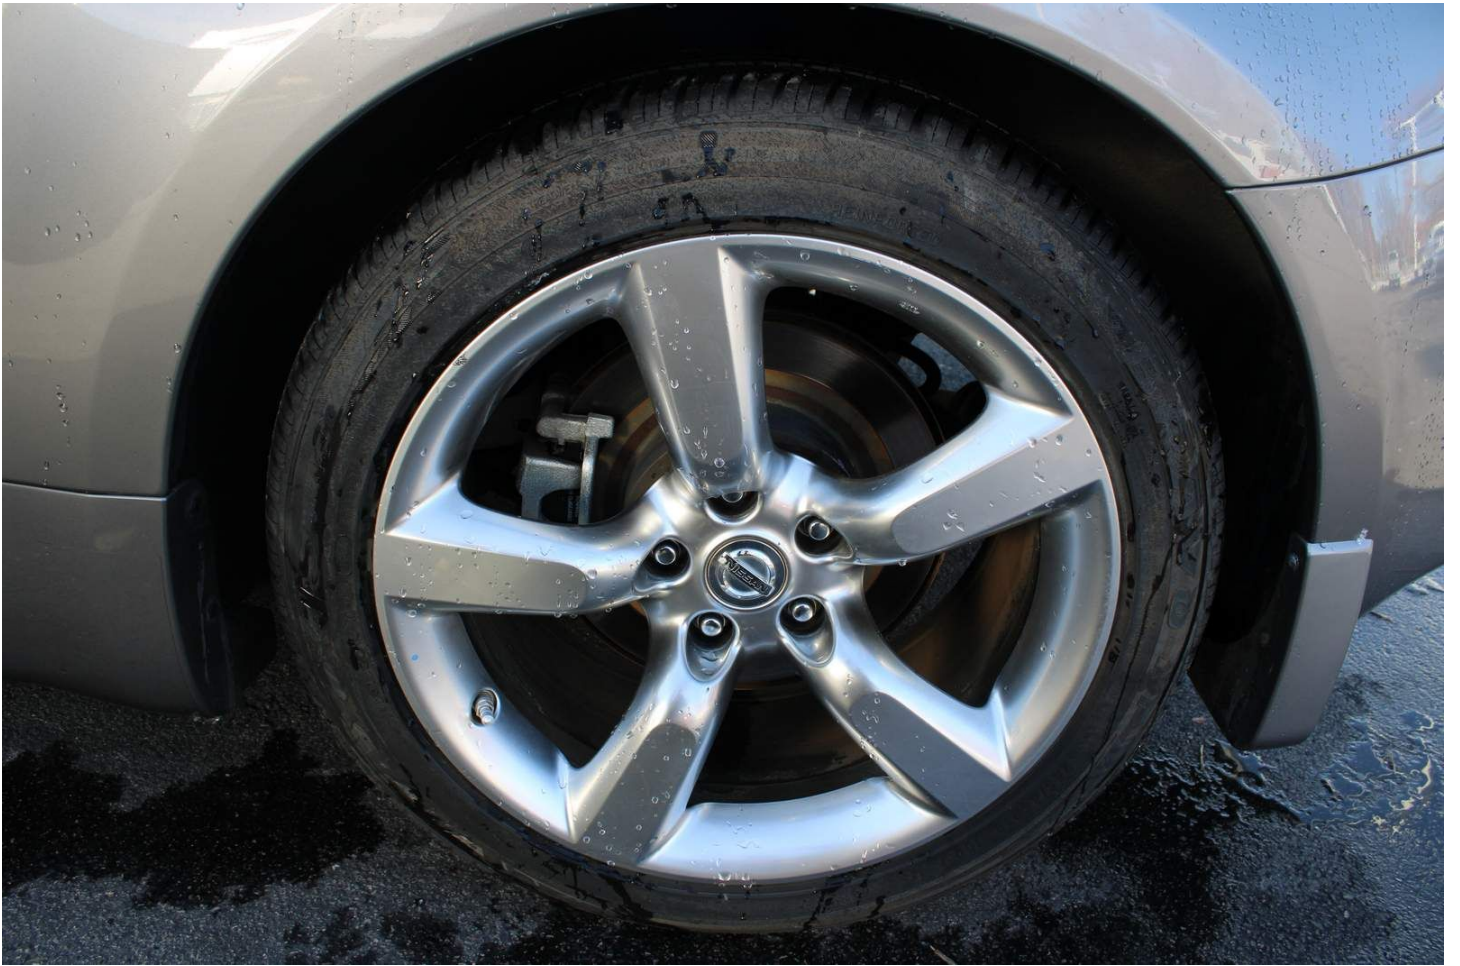
curb rash
