SERVICE BULLETIN

Classification: RA04-001b	Reference: NTB04-065b	Date: November 9, 2005
------------------------------	--------------------------	---------------------------

2003 – 2005 350Z; CLICKING NOISE FROM REAR AXLES

APPLIED VEHICLE: 2003 – 2005 350Z (Z33) Coupe and Roadster

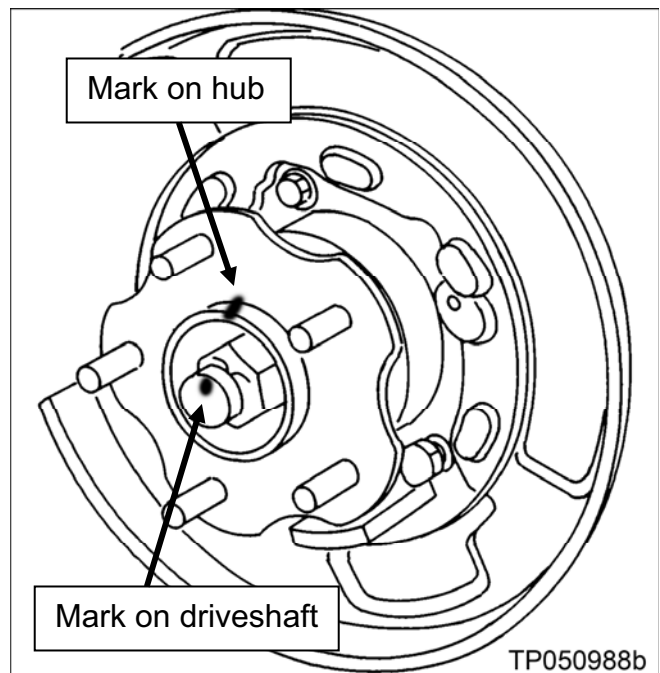
Figure 1

Put a mark on the end of the driveshaft and a matching mark on the hub as shown in Figure 1.

NOTE: These marks will be used when reinstalling the driveshaft.
