Firestone Complete Auto Care
999 Woodbridge Center Dr.
Woodbridge, NJ. 07095

Nissan : 350Z : 2003-05 : with 18" Wheel
 Before Measurements

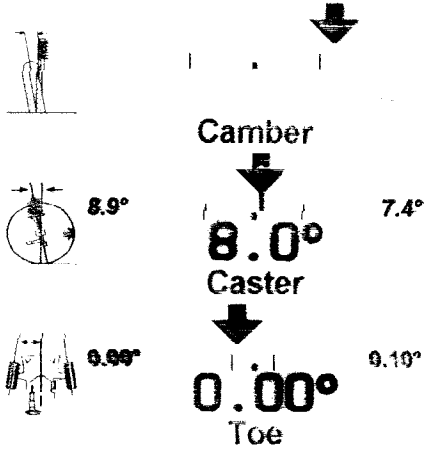
Left Front

- Excessive Camber could cause shoulder wear.
- Negative Camber could cause road shock or poor ride quality.
- Excessive Toe could cause scuffing or shoulder wear.

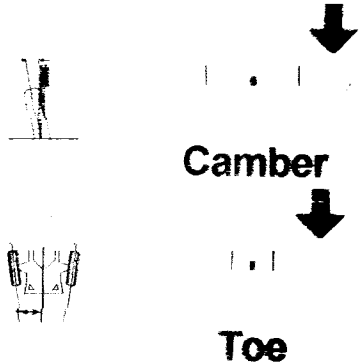
Left Rear

- Excessive Camber could cause shoulder wear.
- Excessive Toe could cause scuffing or shoulder wear.
