SERVICE BULLETIN

Classification: BT03-022a	Reference: NTB03-071a	Date: November 25, 2003
------------------------------	--------------------------	----------------------------

2004 350Z ROADSTER; SOFT TOP INFORMATION

APPLIED VEHICLE: 2004 350Z (Z33) Roadster

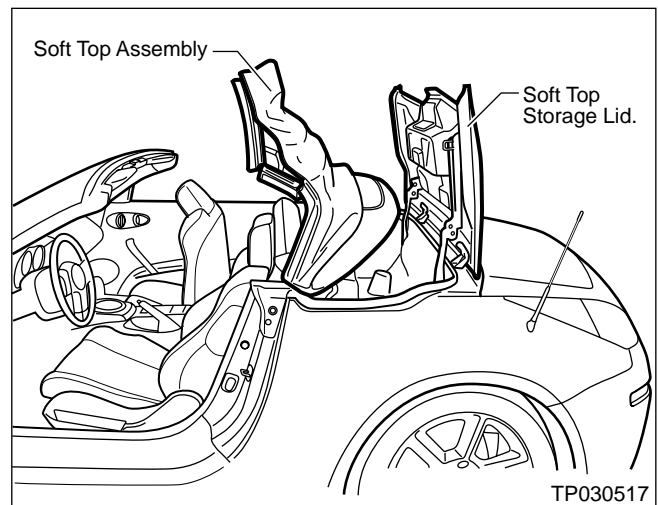
Figure 1

If you confirm an Applied Vehicle has any Soft Top assembly malfunction, including:

- Incorrect Soft Top operation caused by limit switch adjustment or operation.
- Soft Top material blemish or damage from the factory, including damage to the rear window.

- Broken/damaged Soft Top assembly components.
- Soft Top operating motor failure.

Action: Replace the entire Soft Top assembly.

- Refer to the Service Manual (ESM), section RF, for Soft Top replacement instructions.
- Nissan will replace the Soft Top assembly on 350Z Roadsters rather than repairing individual components.
- Authorization from TECH LINE is required for Soft Top assembly replacement.

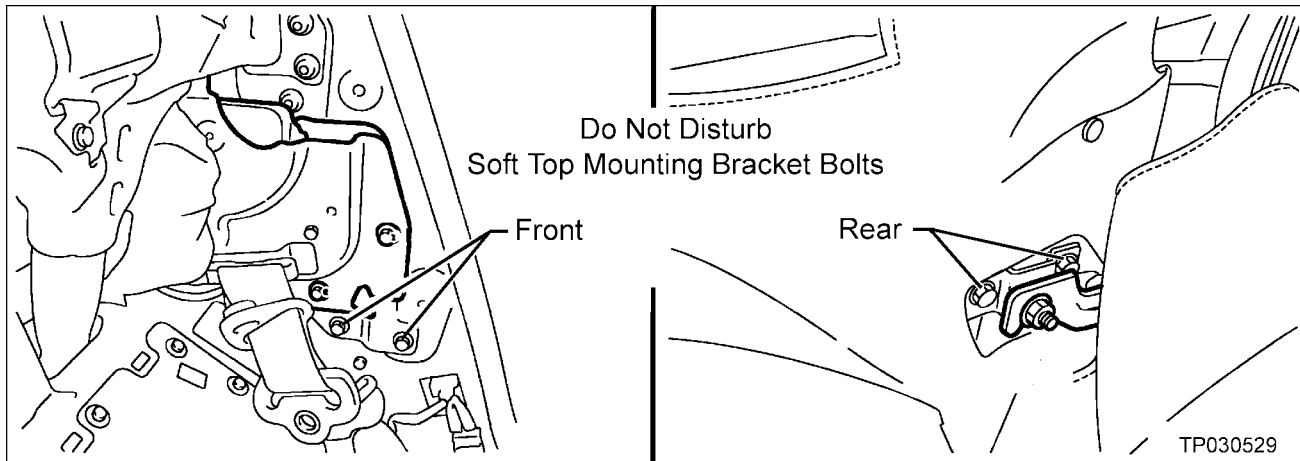
Figure 3

- **Do not “disturb”** (loosen or remove) the bolts shown in Figure 3.
- These bolts secure the Soft Top mounting brackets (left, right, front and rear) to the vehicle body.

- The Soft Top mounting brackets and locating sockets shown in Figures 3 and 4 are very “precisely” (accurately) adjusted at the factory to ensure proper Soft Top fit and function.
- Any change to this adjustment may cause poor fit, resulting in possible water leaks and wind noise.
- If loosened or removed, these items will require the services of a body shop to accurately readjust them.

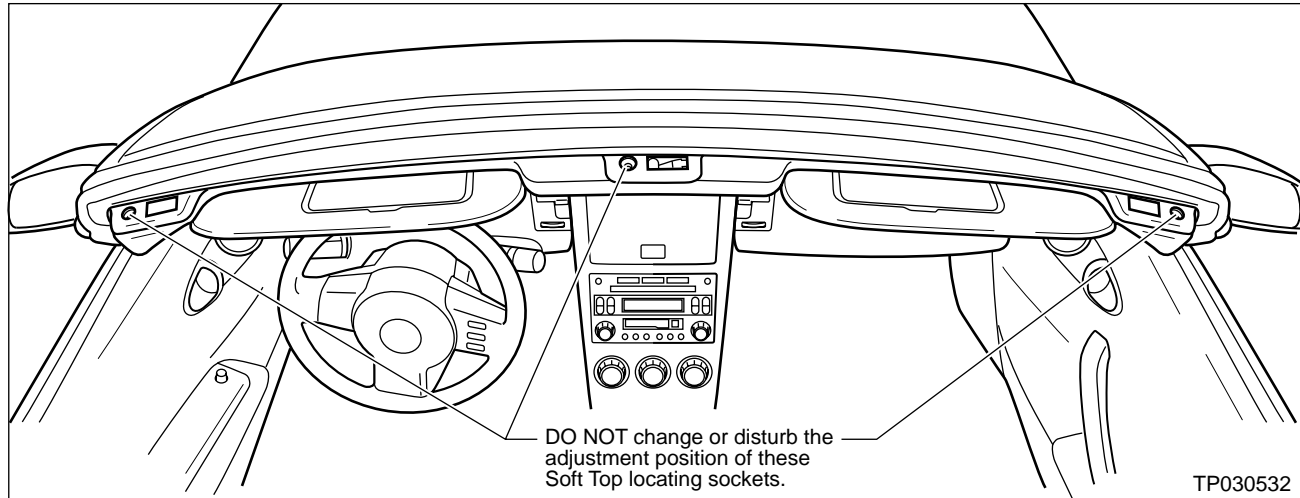
Figure 4

- **Do not “disturb”** (move or change) the adjustment of the Soft Top locating sockets shown in Figure 4.

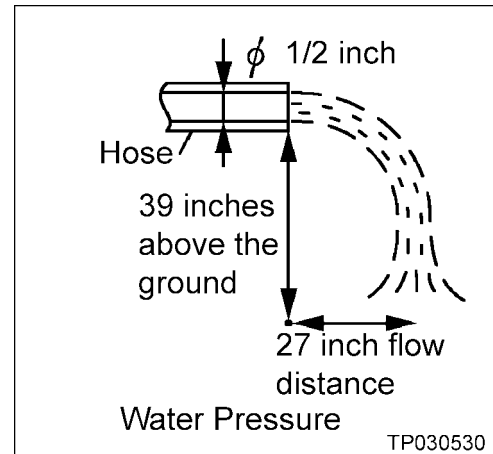
Figure 5

- Use a water hose that has an inner diameter of approximately ½ inch.
- Adjust the water pressure enough to flow out the end of the hose a distance of about 27 inches with the hose 39 inches above the ground (see Figure 5).
