SERVICE BULLETIN

Classification: BT08-029	Reference: NTB08-100	Date: December 18, 2008
-----------------------------	-------------------------	----------------------------

SOFT TOP COVER DOES NOT FULLY OPEN

APPLIED VEHICLES: 2004 – 2008 350Z Roadster (Z33)

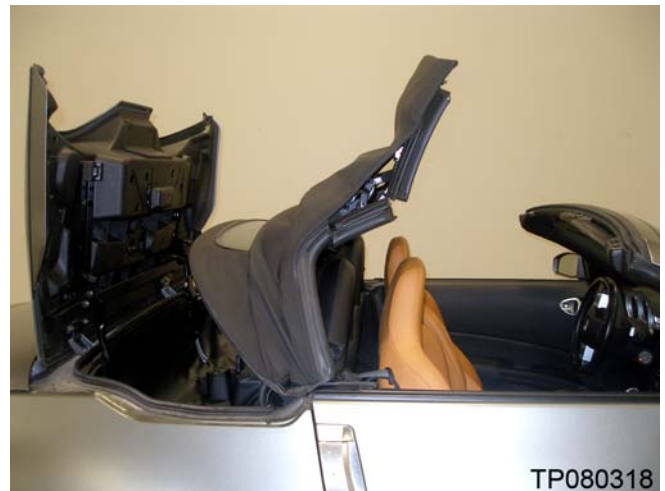
Figure 1

1. Retract soft top cover about 90 degrees.

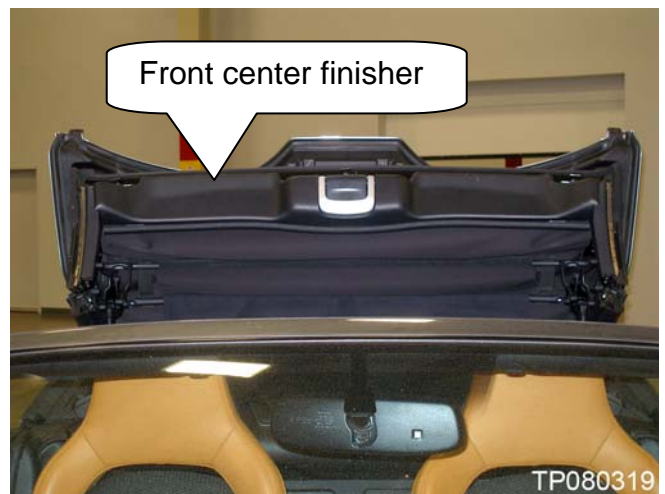
Figure 2

2. Remove front center finisher.

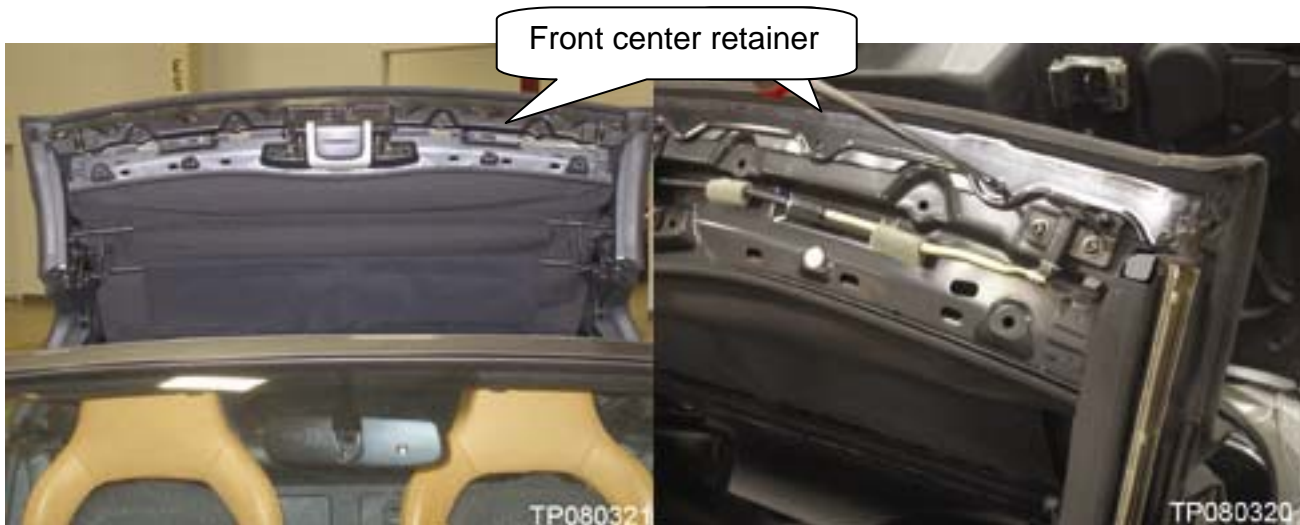
Figure 3

3. Remove front center retainer.

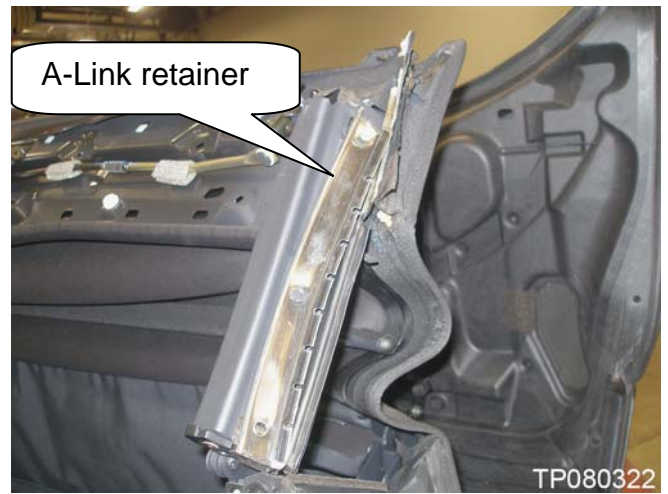
Figure 4

4. Remove A-link retainer (both sides).

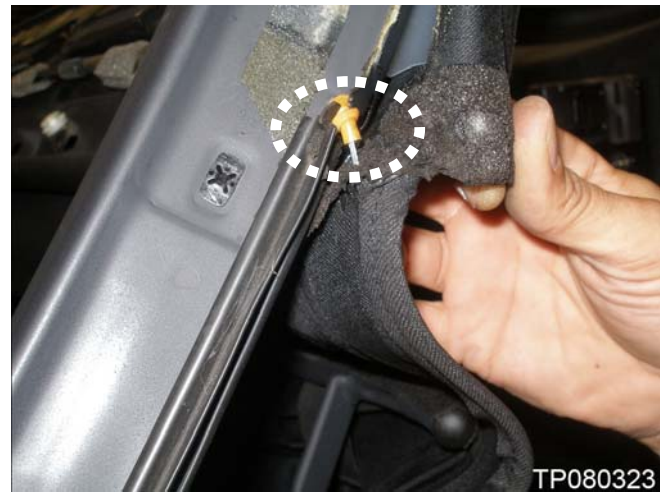
Figure 5

5. Remove the clips from the notch in A-link (both sides). See Figure 5.

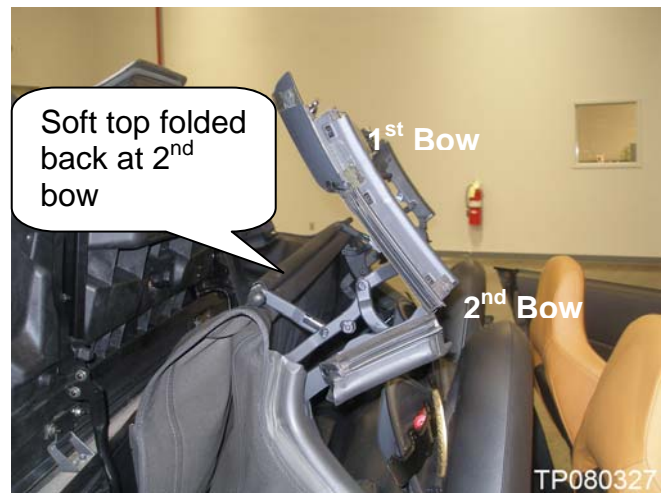
Figure 6

6. Remove the soft top cover from the frame at the 1st bow and fold back at the 2nd bow.

- Make note of the location of double-sided tape which will be replaced when reinstalling parts.

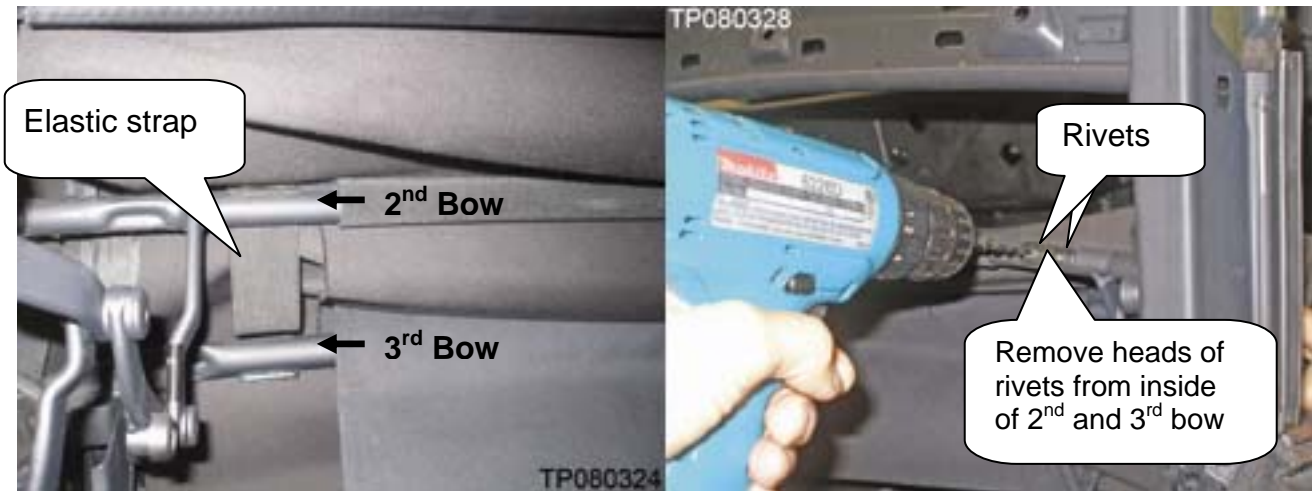
Figure 7

7. Drill out the rivets and remove the elastic strap attached to the 2nd and 3rd bow (both sides).

IMPORTANT: Be careful not to damage the soft top cover, protect the area as necessary.

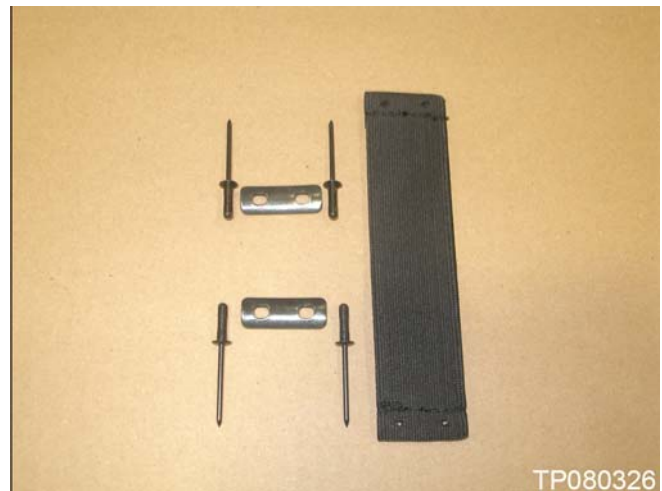
Figure 8

8. Install the elastic straps.
