IMPORTANT: Remember to read the Nissan instructions before starting. I read the Nissan and EZ ON instructions numerous times before starting.

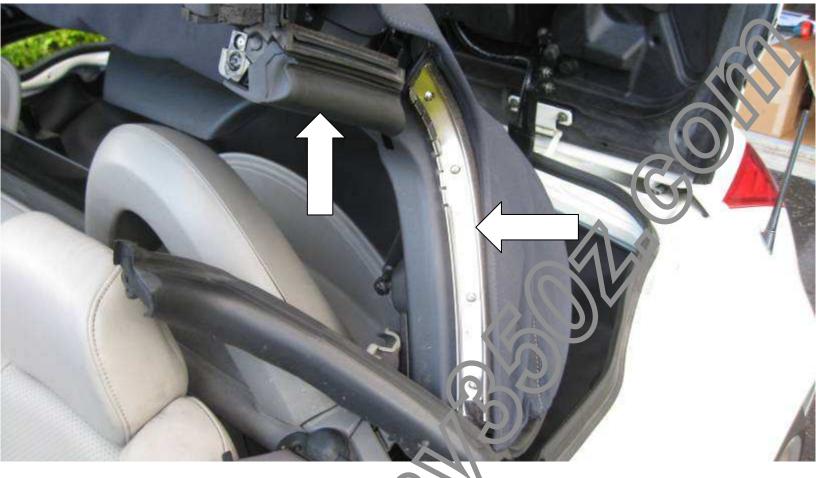
Step 3: After metal bracke' is removed it will look like this.

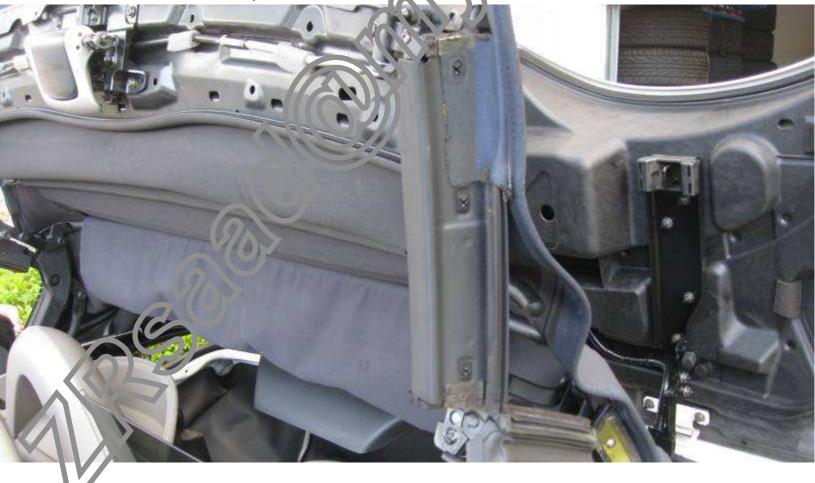
Step 4: Remove all 3 metal brackets (per side) & then you will need to drill out the rivets that held it in place.

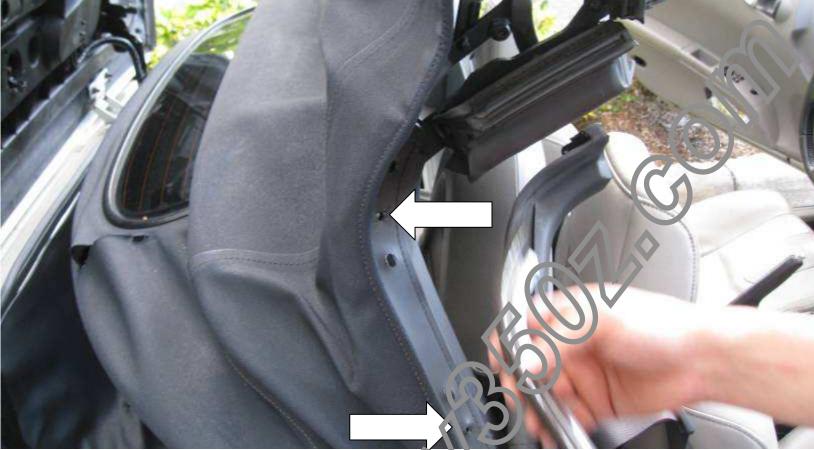
Step 5: Now you are ready to pull off the front part of the top. Remember to be careful while taking it off. Some places use double-sided tape to no ld noin

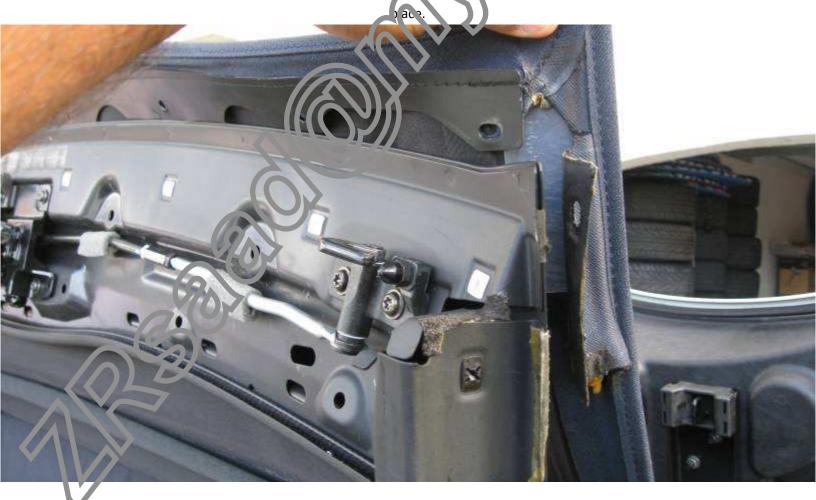
Step 6: Be careful here. You need to pull out this wire from the old top and fish it through the new top with a wire hanger.

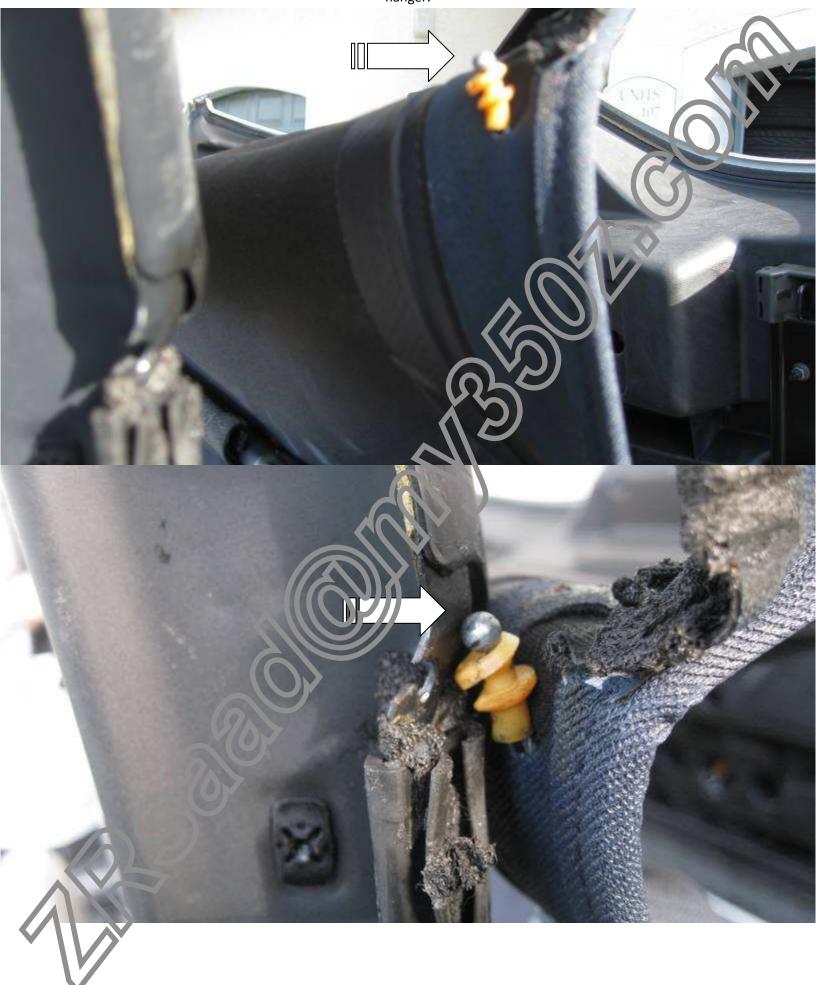
Step 7: There is a metal bracket under the cloth that is fastening the cloth in place. Take a flat head screw driver and slightly bend it back just enough so it releases the cloth.

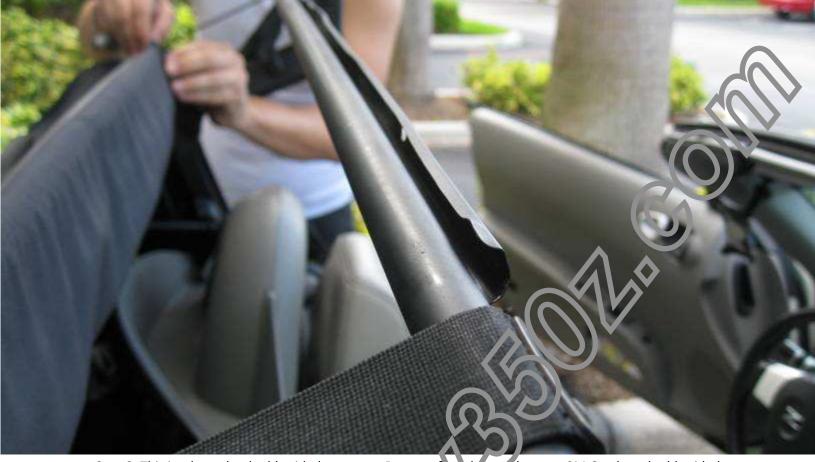
Step 8: This is where the double sided tape was. Remove & replace with a new 3M Outdoor double sided tape

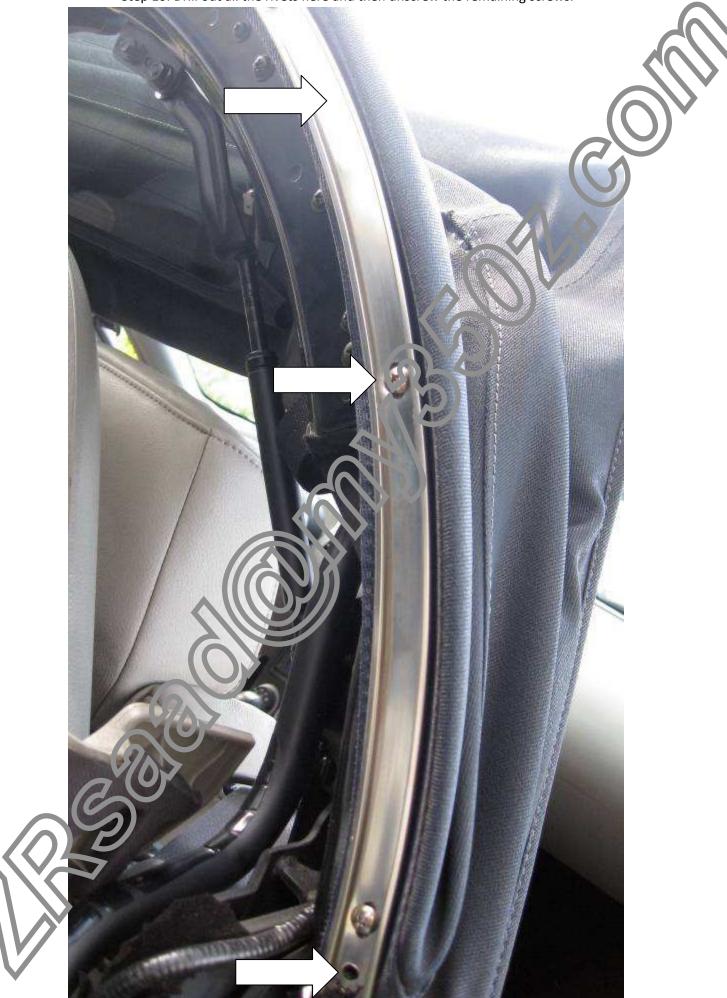
Step 11: Remove the metal bracket and pull off the cloth just enough so it's not in its original

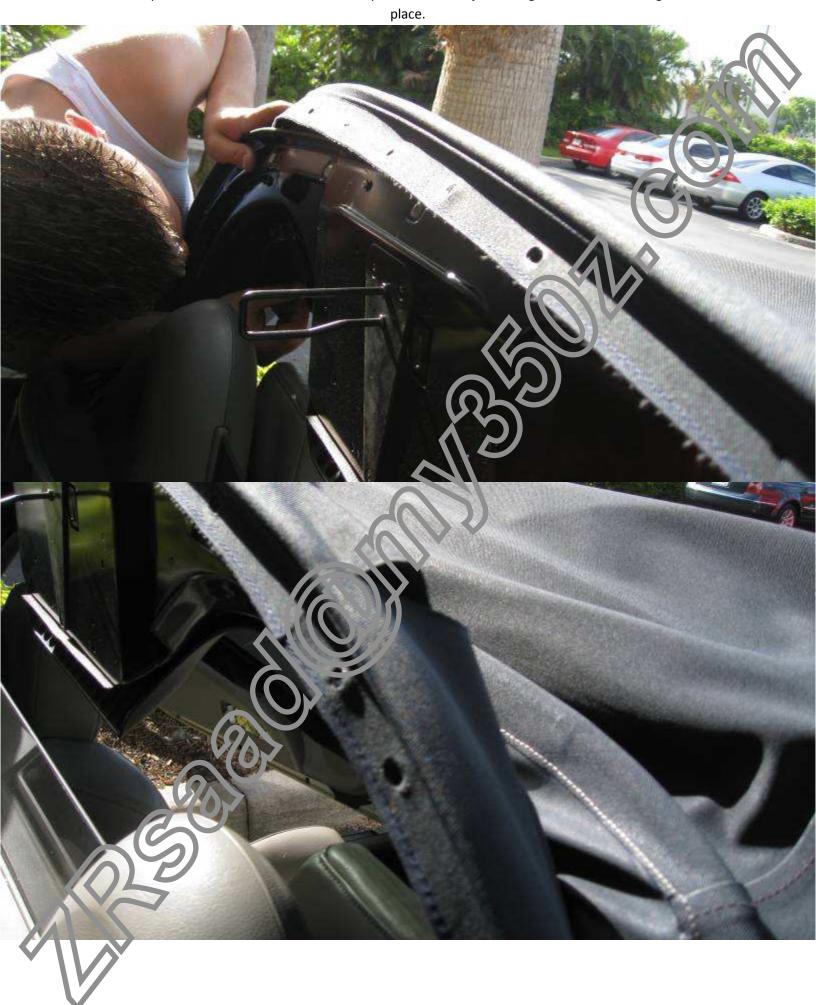
Step 12: Remove the Wire for the defroster and fish it out of the canvas

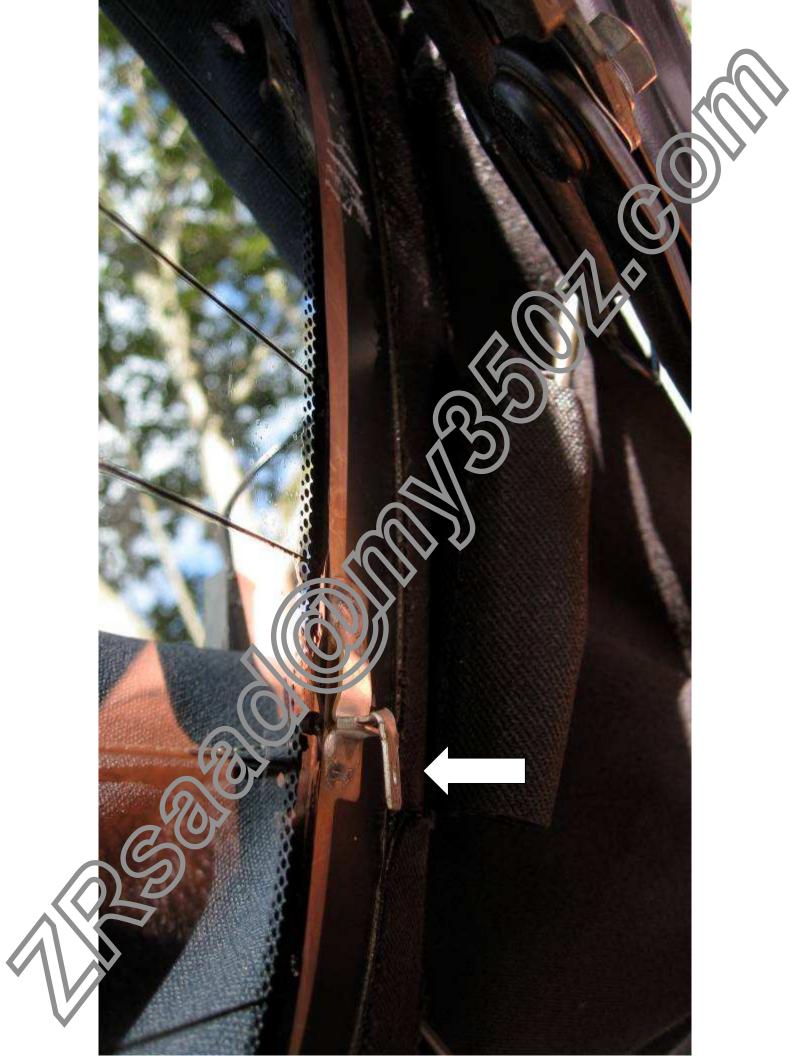
Step 13: This part is a little tricky; you will have to pull down the canvas from the side and get it over/under the metal

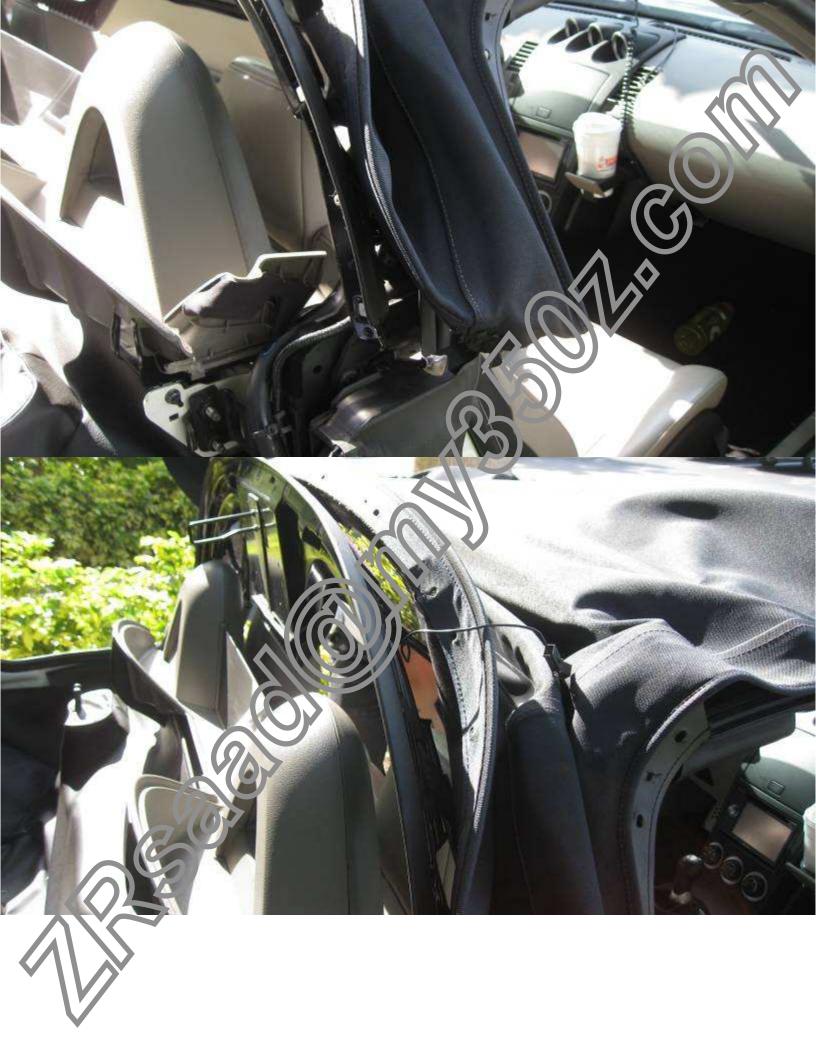
Step 14: Now carefully pull out the metal wire that was inside the loop part of the canvas next to the defroster wire. This is the wire that causes the tears on both side of the glass. This is cause by usage and stress on the canvas causing it to tear.

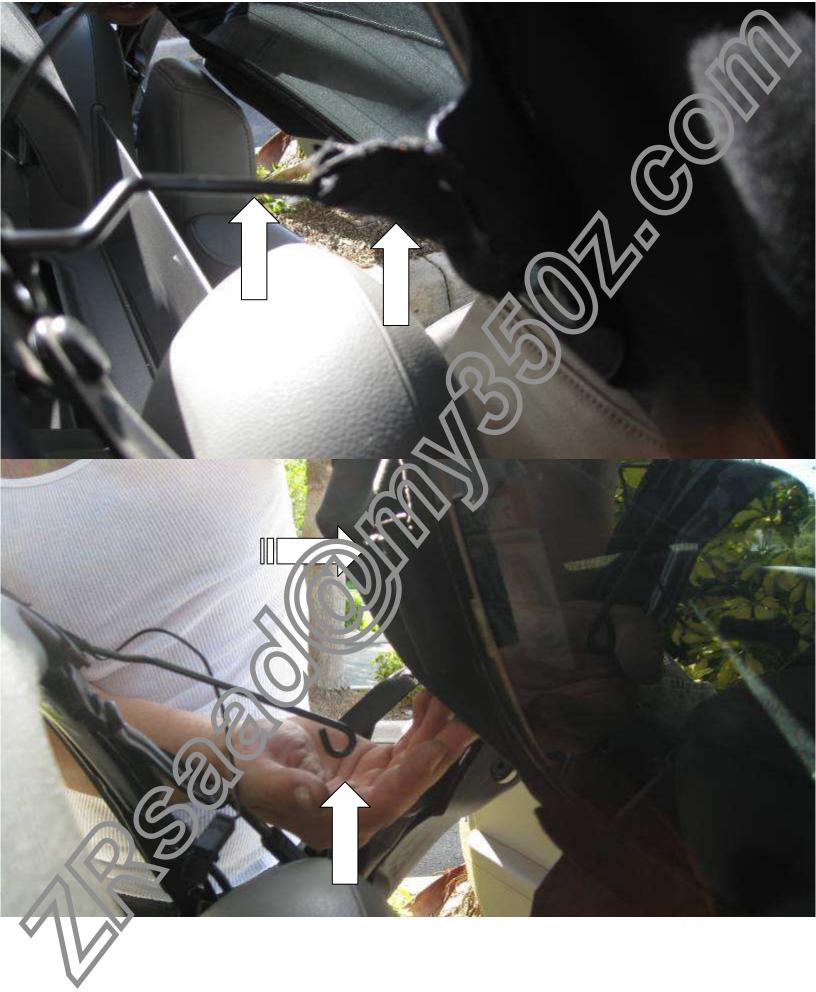
Step 15: Undo the Velcro from the inside of the Canvas. This is the tension cloth that should be tight from the inside.

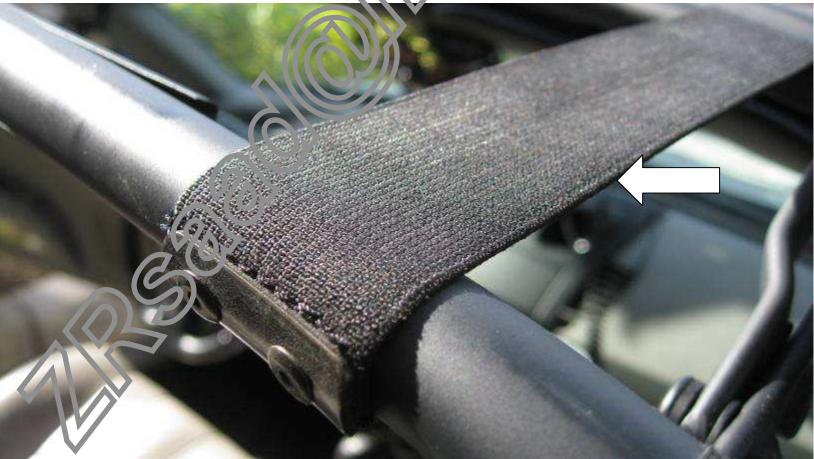
Step 17: Remove this felt tape carefully as you will need to reuse it

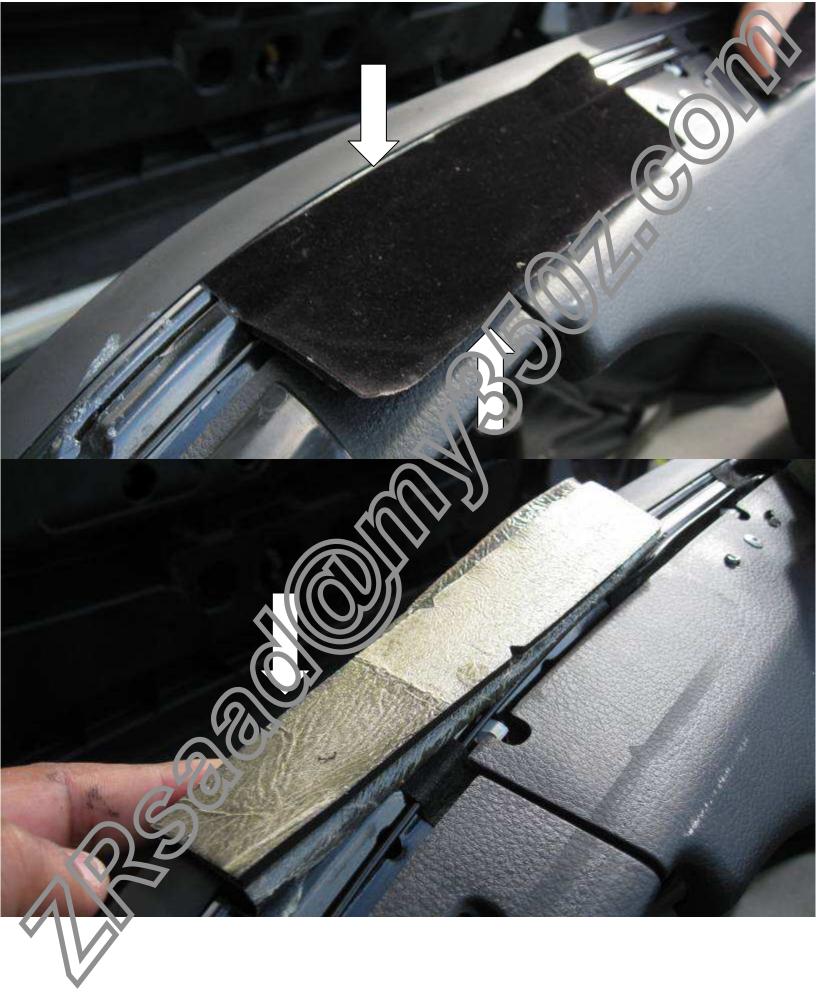
Step 18: Put new 3M Double-Sided

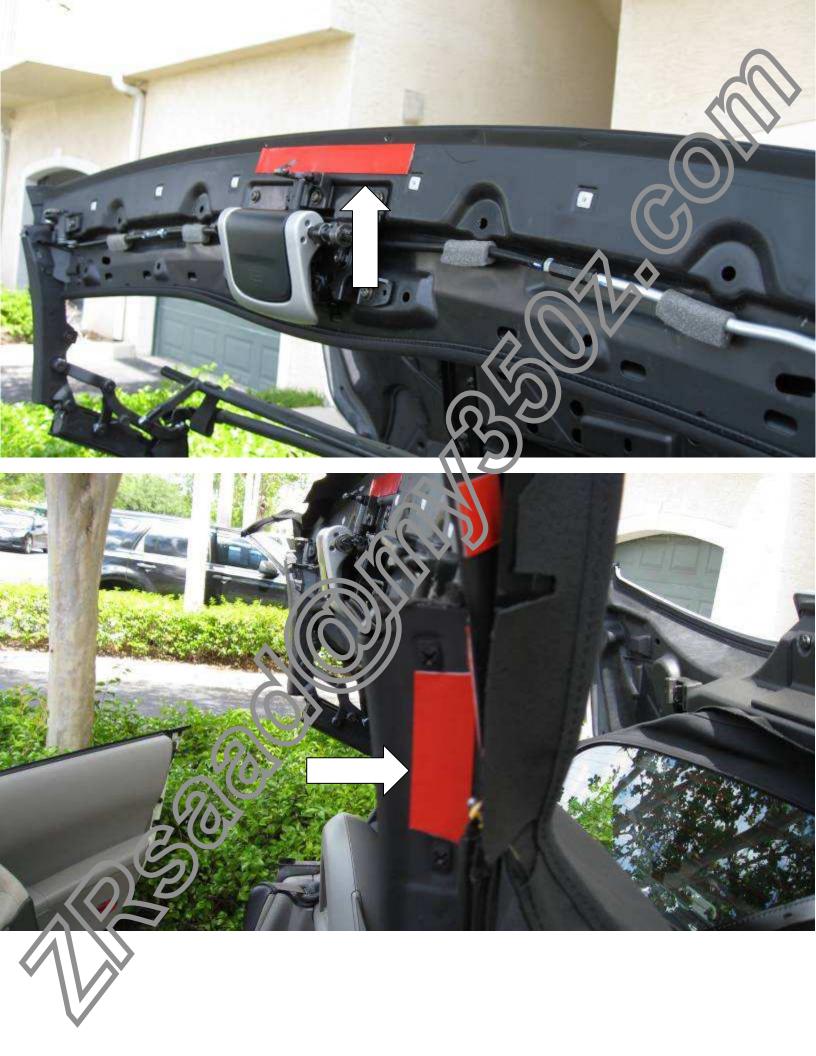
Step 19: Now we will start putting on the new canvas top. Start from the part where we removed the inside of the top from the 3rd and 4th bow. Don't forget to bend the metal back into place because while removing the old canvas we bent it outward slightly.

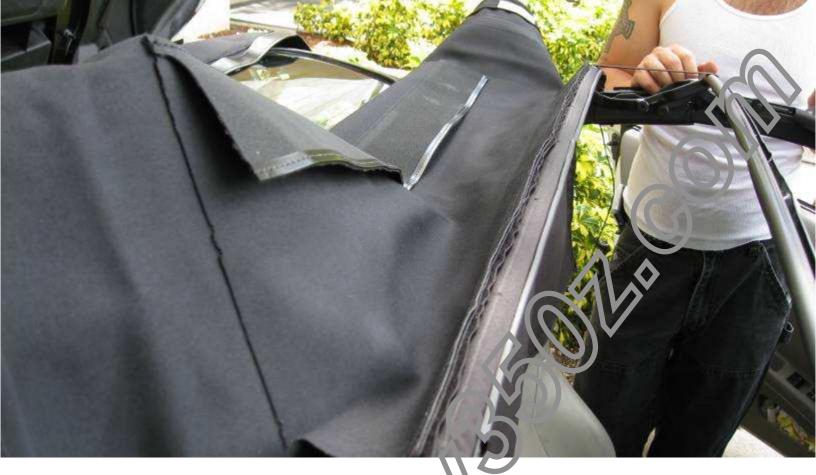
Step 20: Do the same for the other bow in front of that

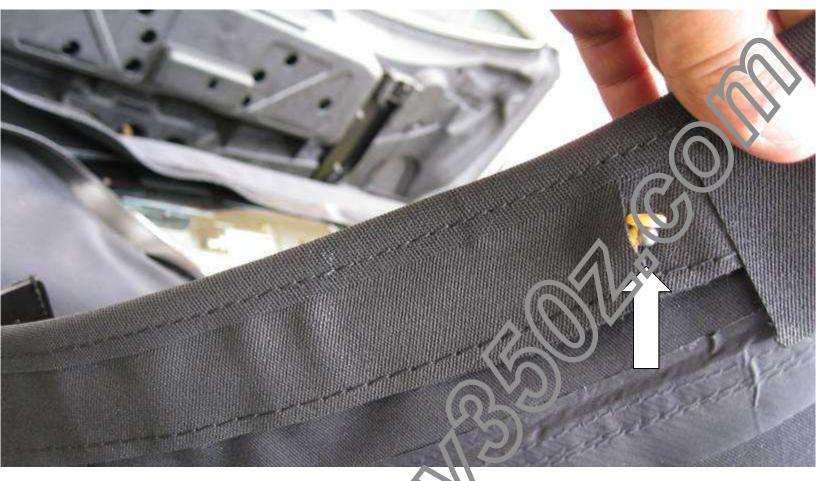
Step 22: Now let's work on the front of the canvas. Now let's remove the side 3M Tape and screw in the metal bracket over the new canvas. Do the sime for both sides.

NOTE: THIS IS ONLY FOR THE TOP SIDE OF THE CANVAS, NOT THE LOWER SIDE. REFER TO PICS

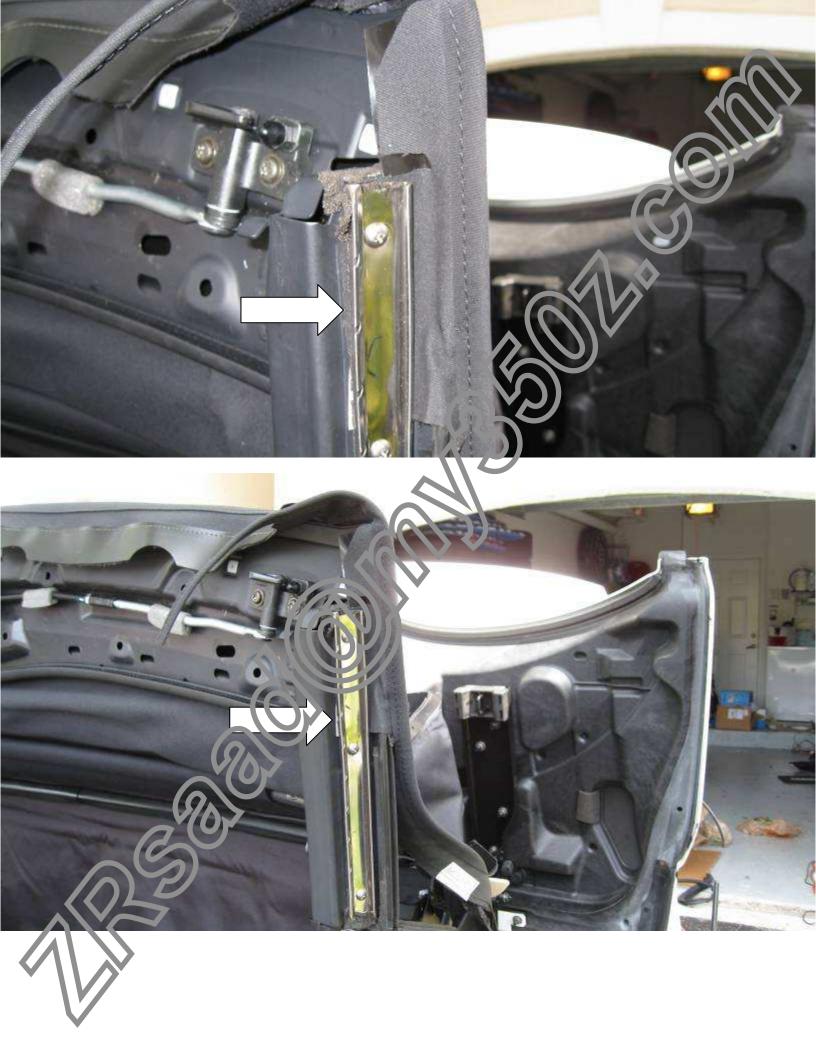
Step 23: You will need to fold it in place and then remove the 3M tape and screw it into place. Do the same thing for the other side and work you're your way to the middle.

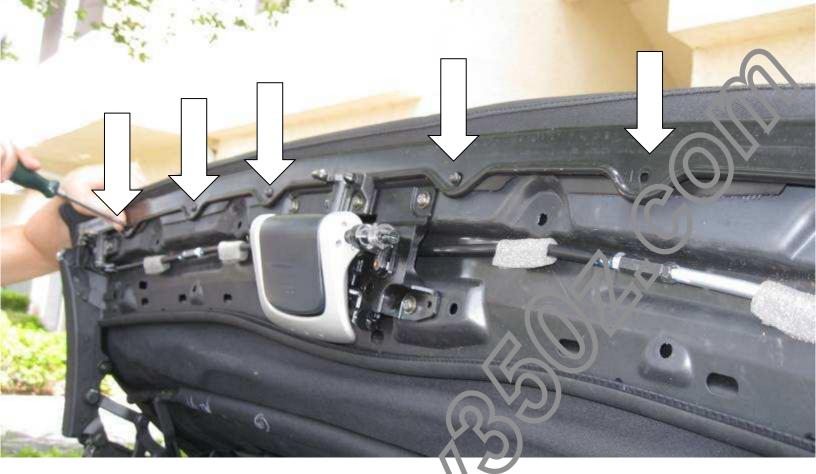
NOTE: DO NOT REMOVE THE LONG 3M TAPE UNTIL A WEEK LATER SO THE TO? WIL L GET STRETCHED. YOU CAN GET TO THE LONG RED 3M TAPE LATER BY REACHING YOUR HAND IN FIC M THE INSIDE OF THE CAR.

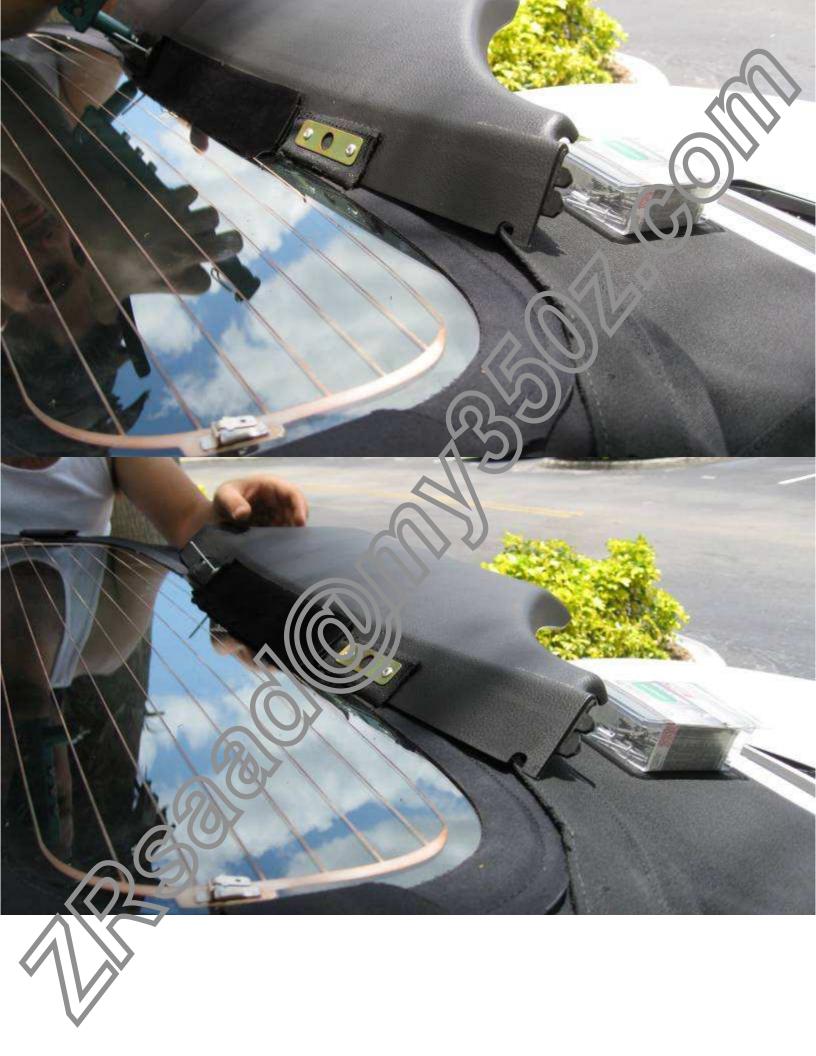
Step 25: Snap the 5th Bow motor cover back in its place and put the felt tape back on the motor cover.

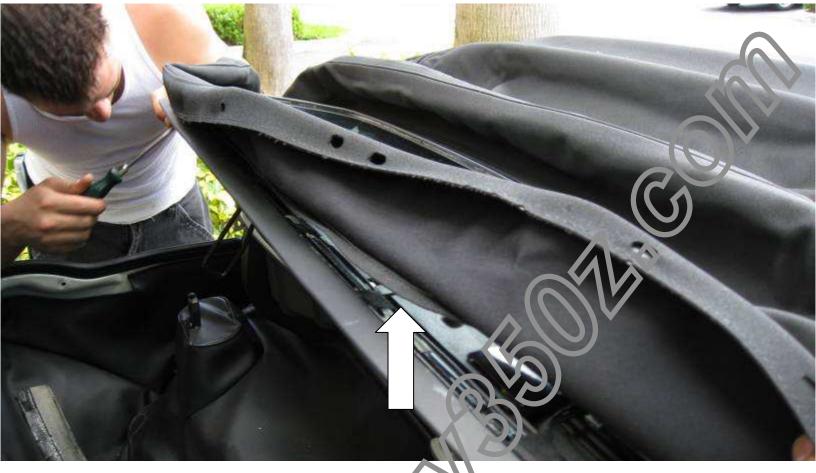
Step 26: Now we want to pull the canvas over the back of the 5th low. Just pull it over, do not screw it in yet.

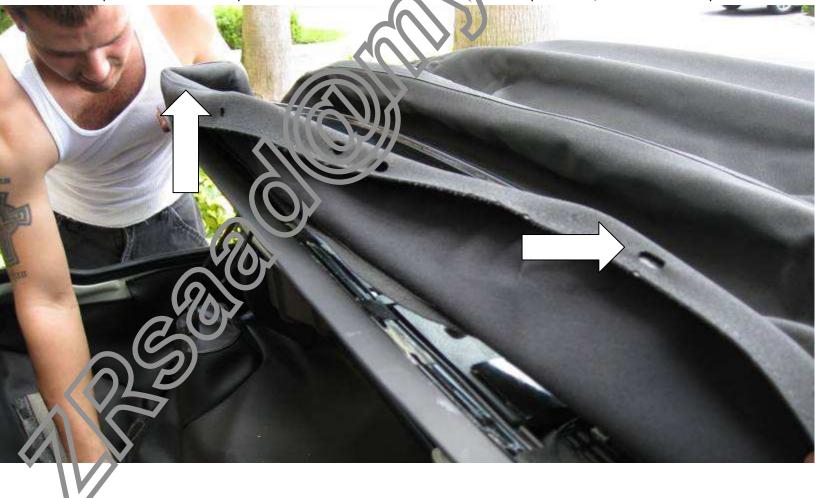
Step 27: This part is just as tricky as it was to get it off. You will need to pull the canvas down while you try to get it over the edge.

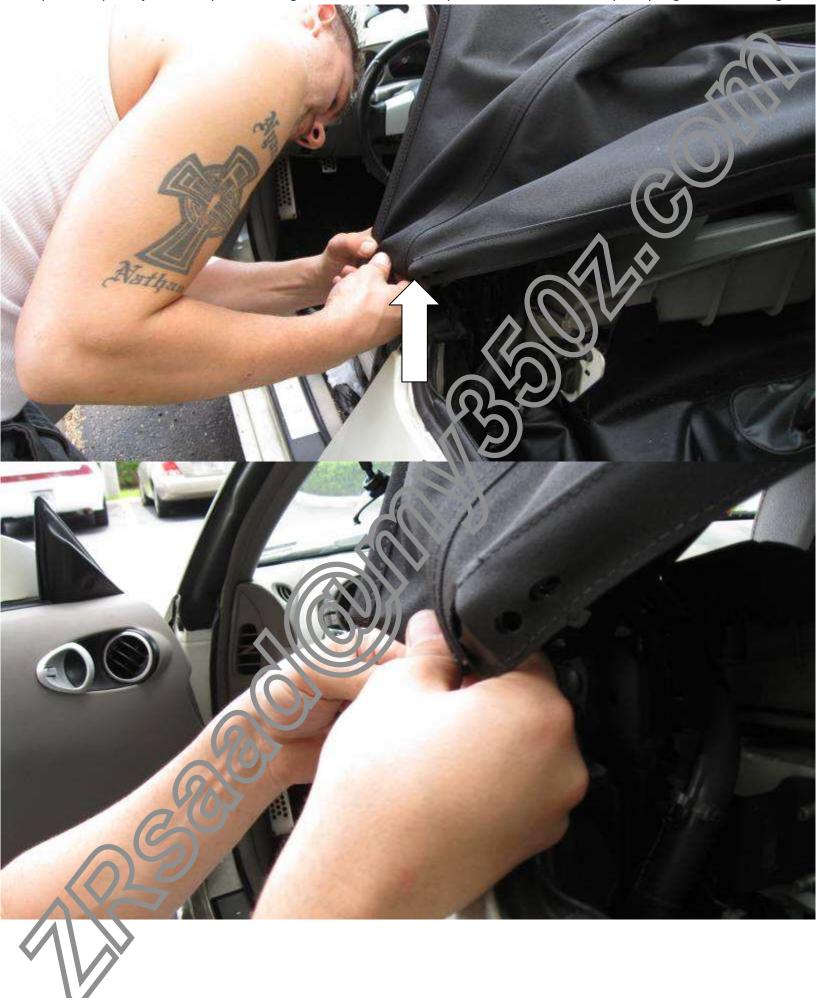
Step 28: Once you get it over the edge you can now rivet both sides. DON'T PUT THE METAL BRACKETS ON YET.

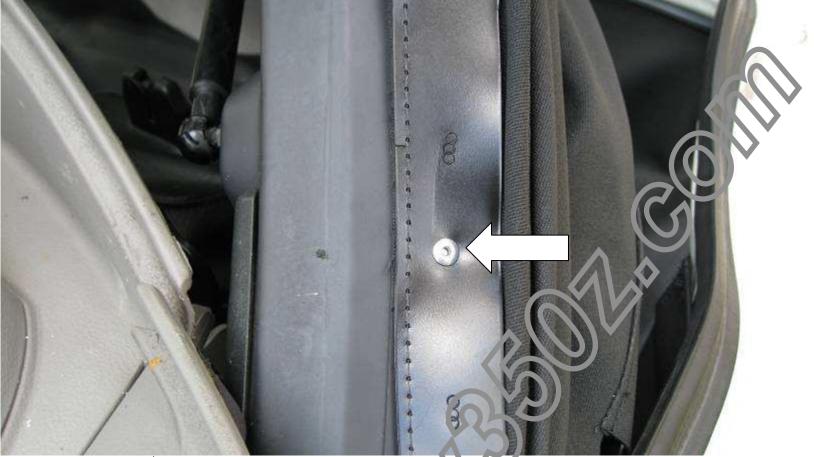
Step 29: Now put the 5th Bow up in the air and start working on the rear. St rt, com the center and put one screw in there and you're your way down doing one side and than the other side.

NOTE: THIS GETS A LITTLE DIFFICULT. YOU WIT NEED TO REALLY STRETCH THE CANVAS NOW.

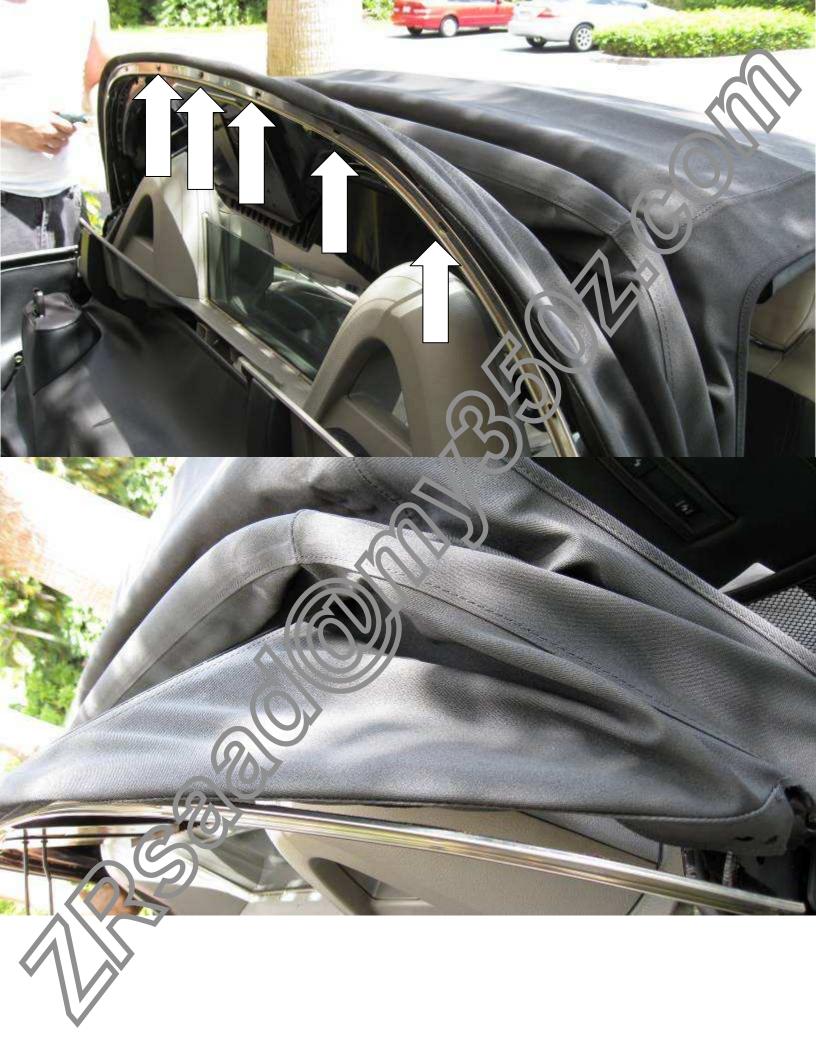
Step 30: Now after putting in about 6 screws it looked like the top was not fitting correctly. This did kind of worry me. So what we did was put the top down all the way, meaning closed it. This stretched out the canvas really nicely and made the last steps of riveting much easier.

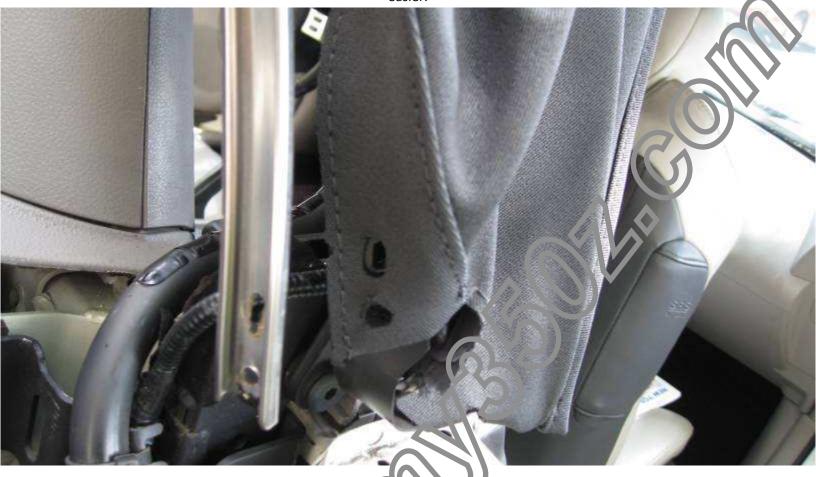
NOTE: Here you can see the ripples or stretch in the canvas that I vas taking bout. This goes away in a week once it's stretched out.

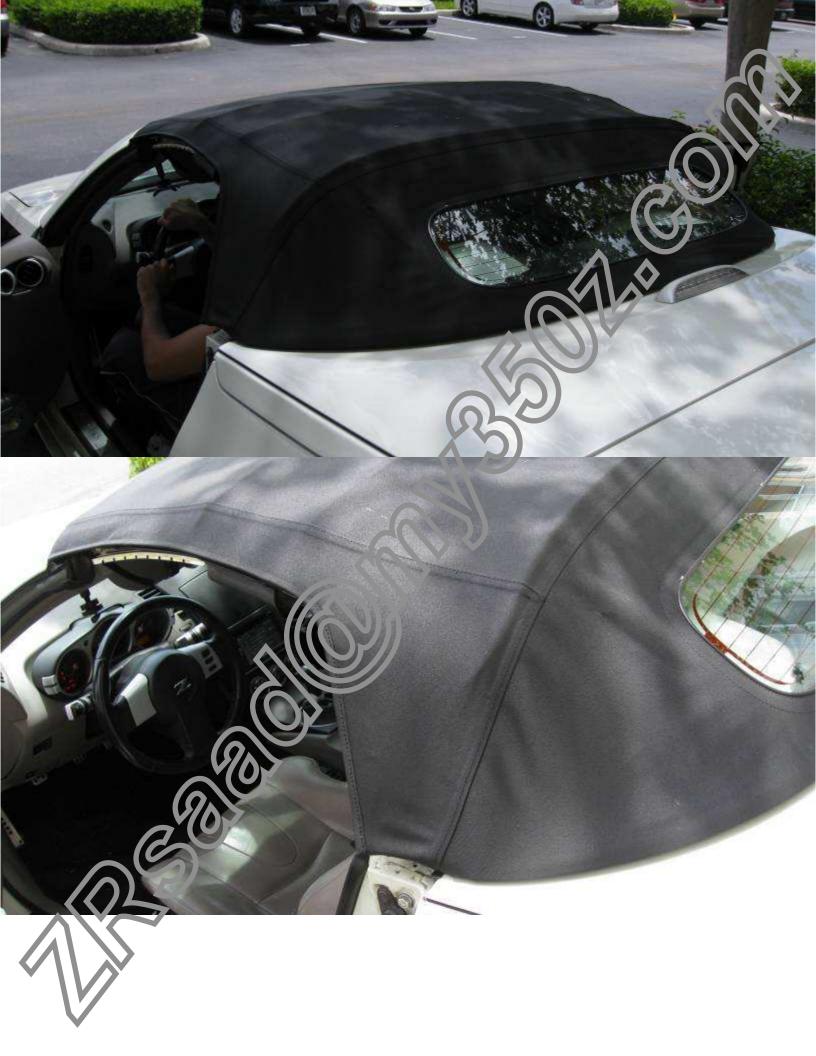
Step 31: Now we open the top back up to complete the work. Finish screwing the metal brackets on both sides.

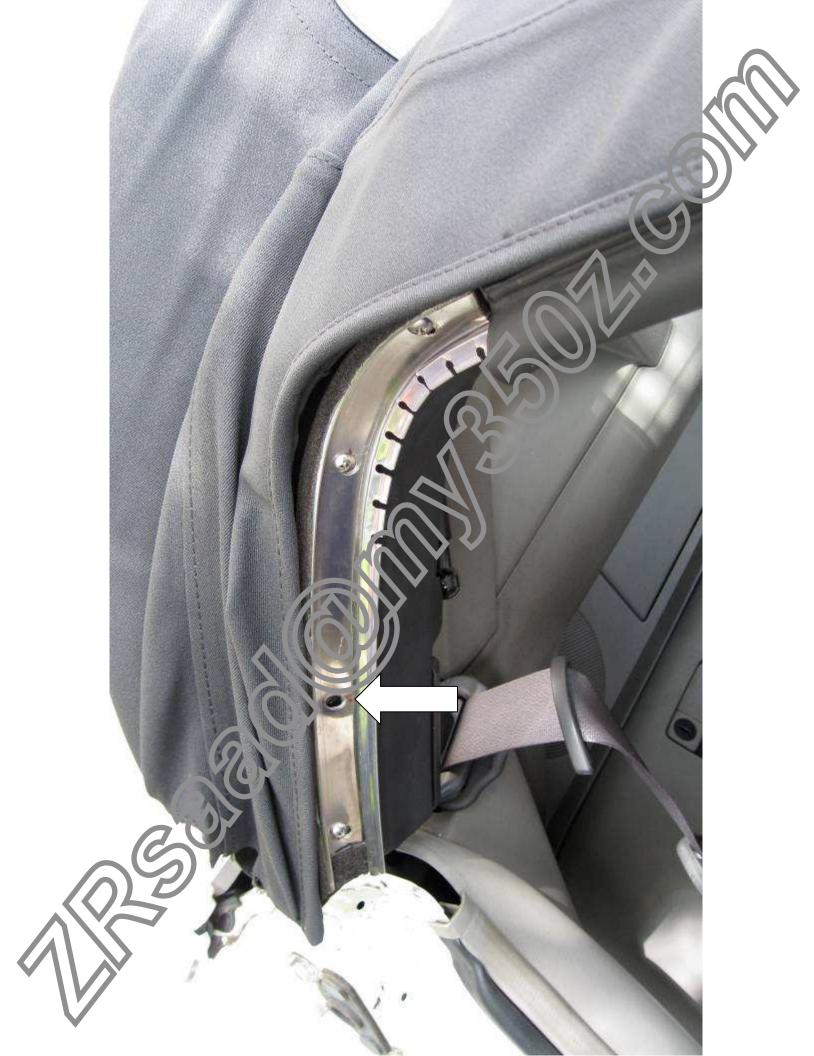
Step 32: Recheck your work. Make sure all screws and rivets have been installed. Then you can complete the work and install the rubber grommets in place.

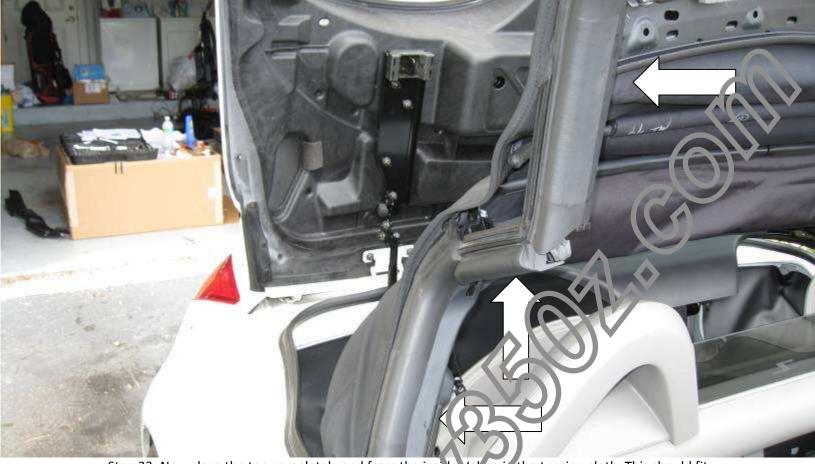
Step 33: Now close the top completely and from the inside /el. roin the tension cloth. This should fit

snu^r .
