Firestone Complete Auto Care
999 Woodbridge Center Dr.
Woodbridge, NJ. 07095

Nissan : 350Z : 2003-05 : with 18" Wheel
 Before Measurements

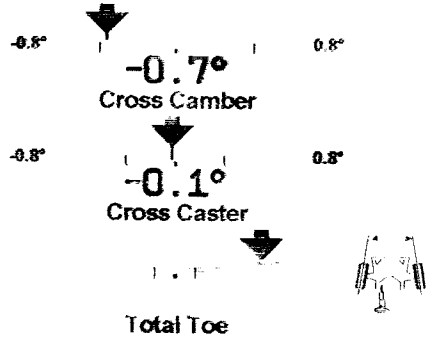
- Excessive Camber could cause shoulder wear.
- Negative Camber could cause road shock or poor ride quality.
- Excessive Toe could cause scuffing or shoulder wear.
