# SERVICE BULLETIN

| Classification:<br>EC03-004 | Reference:<br>NTB03-023 | Date:<br>March 15, 2003 |

## 2002-2003 MAXIMA & ALTIMA: LACK OF POWER

**APPLIED VEHICLES:** 2002-2003 Maxima (A33)  
2002-2003 Altima (L31) **only** with V6 (VQ35) engine.

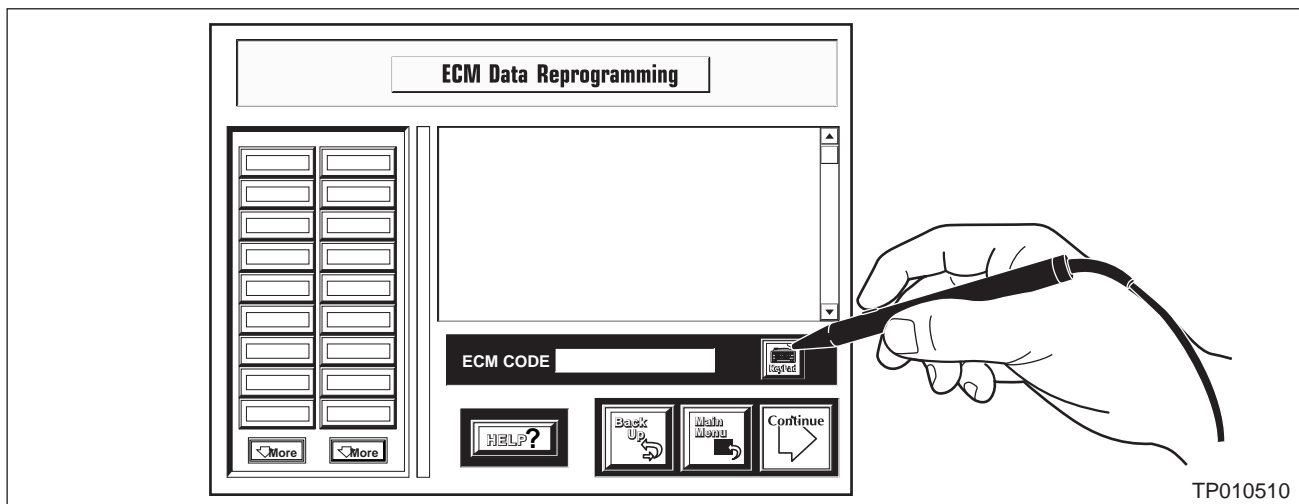
Figure 1

1. Click on the **Keypad** button (see Figure 1).

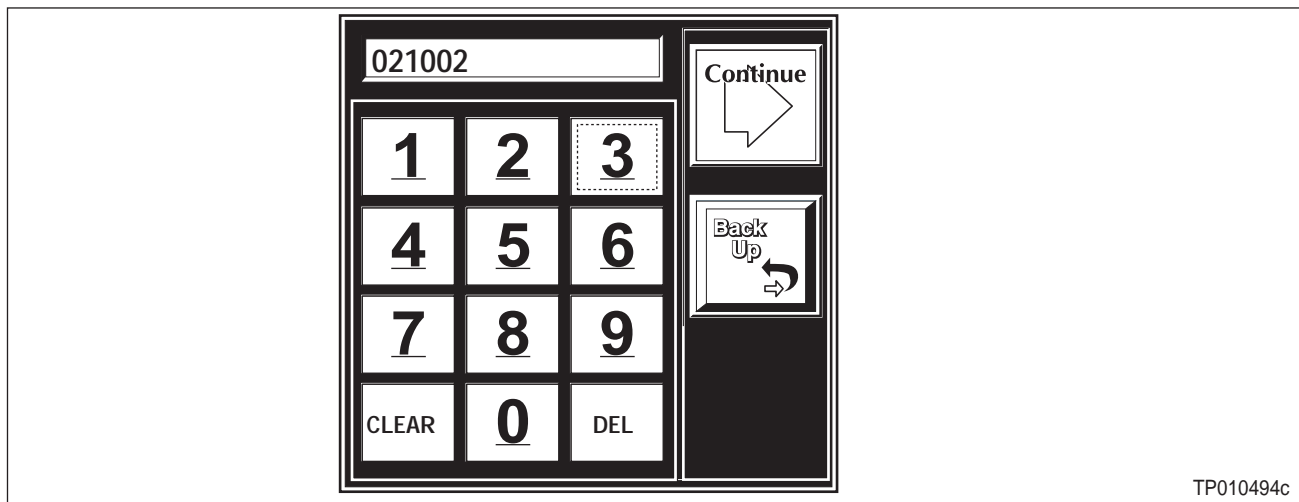
2. Use the digit keys on the **Keypad** (see Figure 2 below) to enter the correct **ECM ID Code** from Chart A-1 or A-2 (page 2).

3. Then click the "Continue" button on the keypad.
