TROUBLE DIAGNOSIS

Component Parts Location

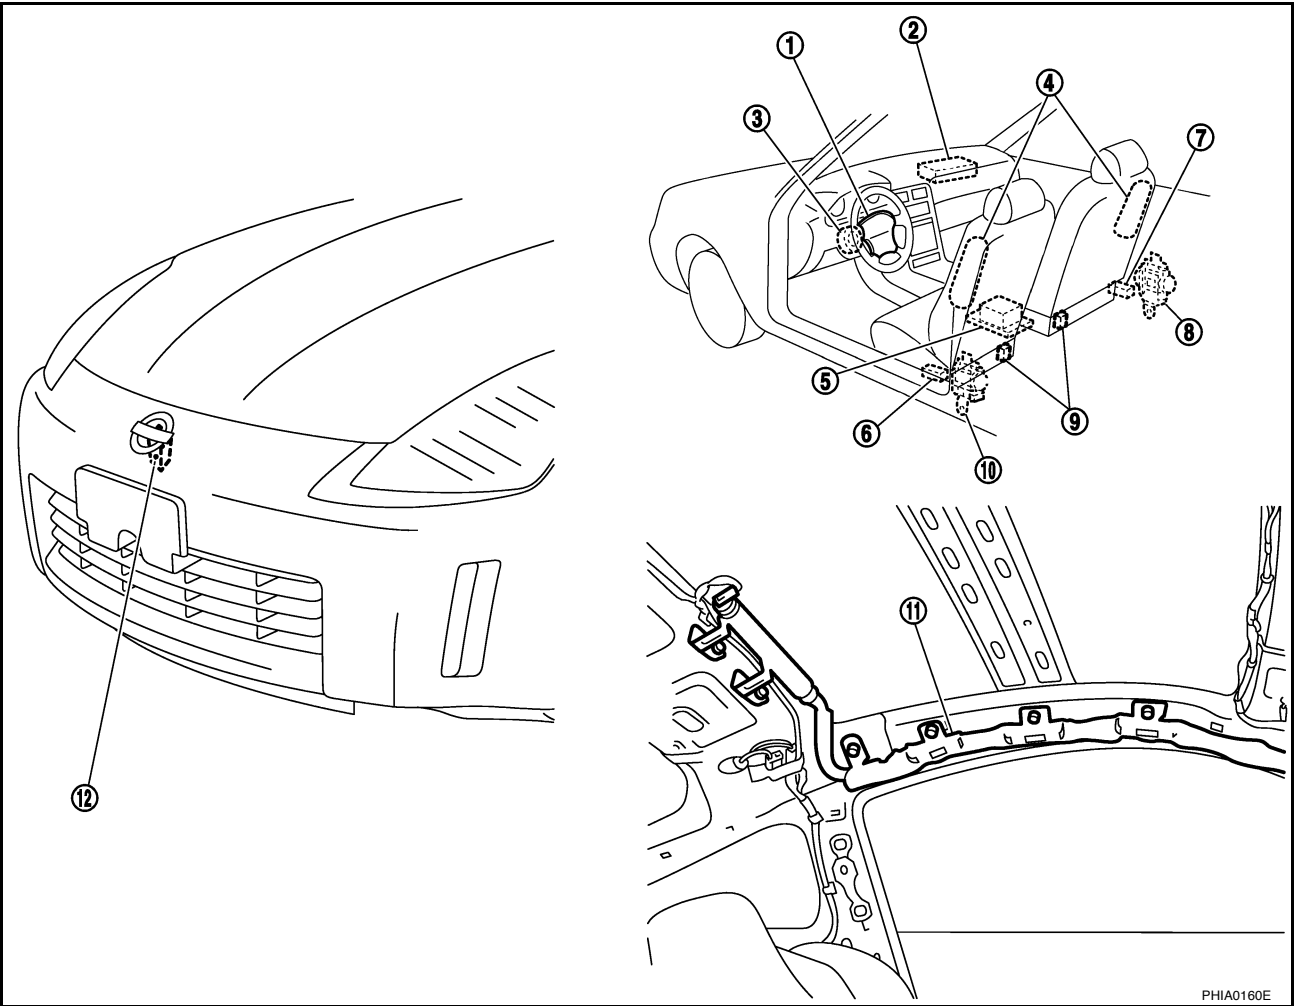
AHS0001U

| 1. Driver air bag module | 2. Front passenger air bag module | 3. Spiral cable |
| 4. Front side air bag module | 5. Diagnosis sensor unit | 6. Side air bag (Satellite) sensor LH |
| 7. Side air bag (Satellite) sensor RH | 8. Seat belt pre-tensioner RH | 9. Seat belt buckle switches |
| 10. Seat belt pre-tensioner LH | 11. Side curtain air bag module* | 12. Crash zone sensor |

*: For Coupe
