# SERVICE BULLETIN

Classification: BT04-016	Reference: NTB04-059	Date: May 13, 2004
-----------------------------	-------------------------	-----------------------

## 2003-2004 350Z; FUEL FILLER LID DOES NOT OPEN ON FIRST PUSH OF RELEASE BUTTON

**APPLIED VEHICLES:** 2003-2004 350Z (Z33) - Coupe and Roadster

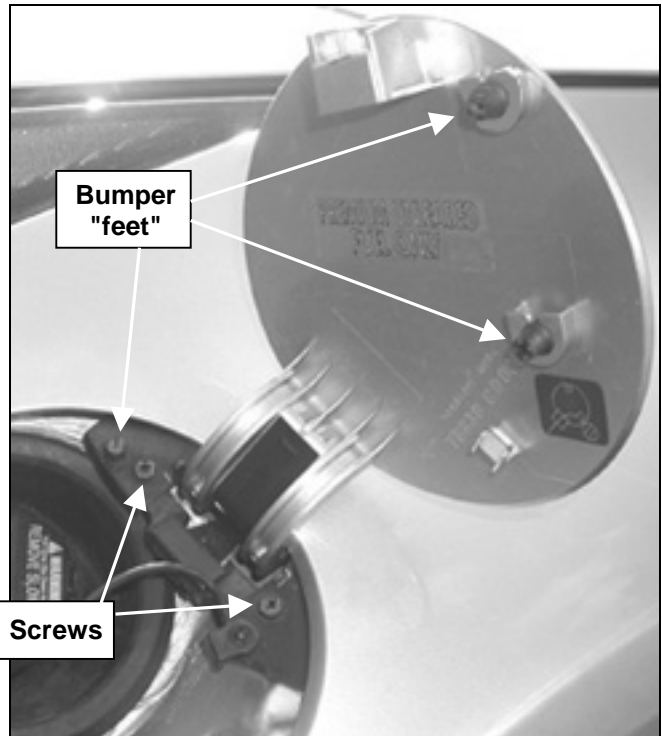
Figure 1

2. Remove the fuel filler lid.
  - You will do this by removing the 2 screws shown in Figure 1.

3. Twist the 3 bumper "feet" until they come off (see Figure 1).

**IMPORTANT:** The new and old bumper "feet" look very similar. Make sure to discard the old bumper "feet" once you remove them.

4. Install 3 new bumper "feet" listed in the Parts Information.

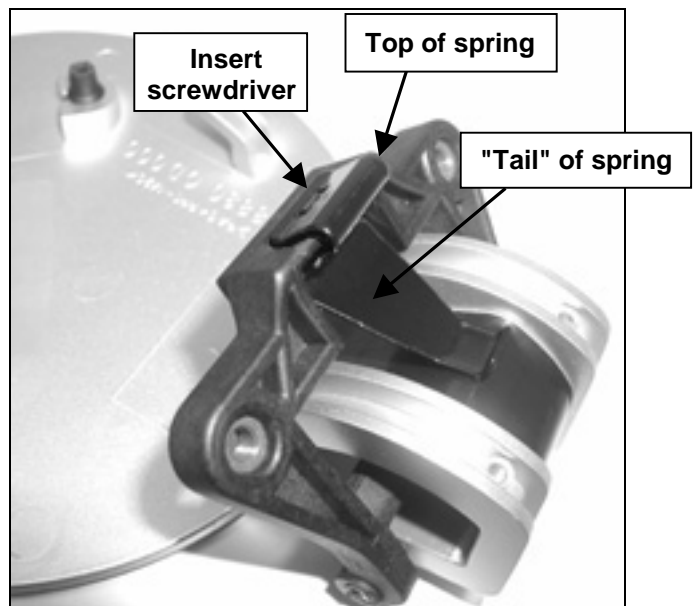
Figure 2

- a. Raise the "tail" of the spring with your finger (see Figure 2).

- b. Insert a flat-head screwdriver under the top of the spring and loosen it from its position (see Figure 2).

**IMPORTANT:** The new and old "opening" springs look very similar. Make sure to discard the old spring once you remove it.

5. Install the new spring listed in the Parts Information.
