# Inspection Report

Report Number: 707687

Report #707687

2008 Nissan 350Z

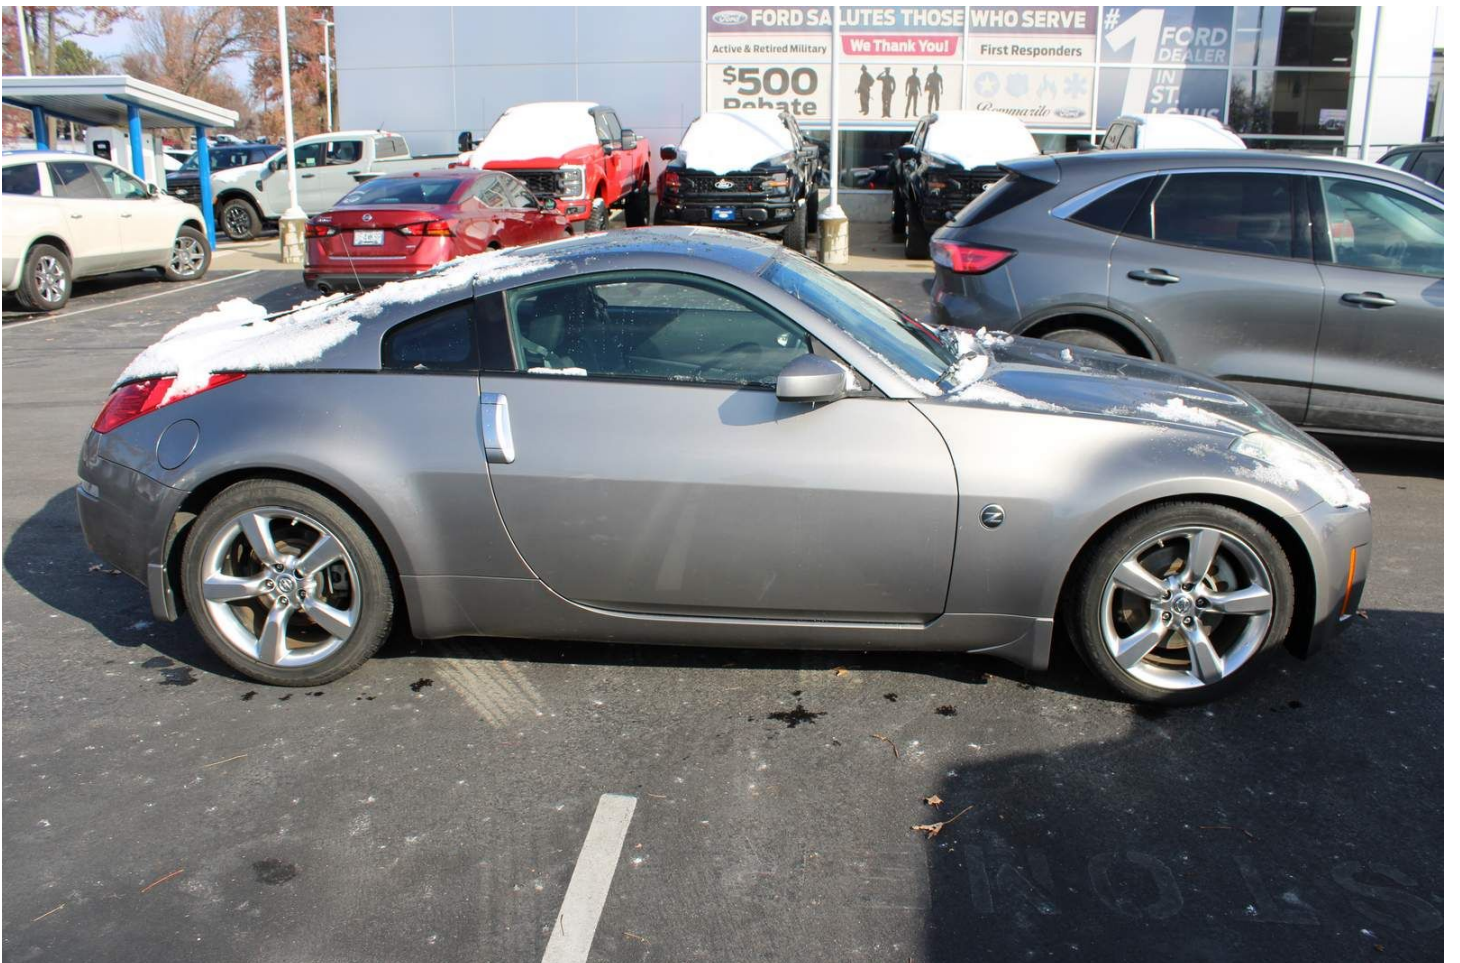
scratch

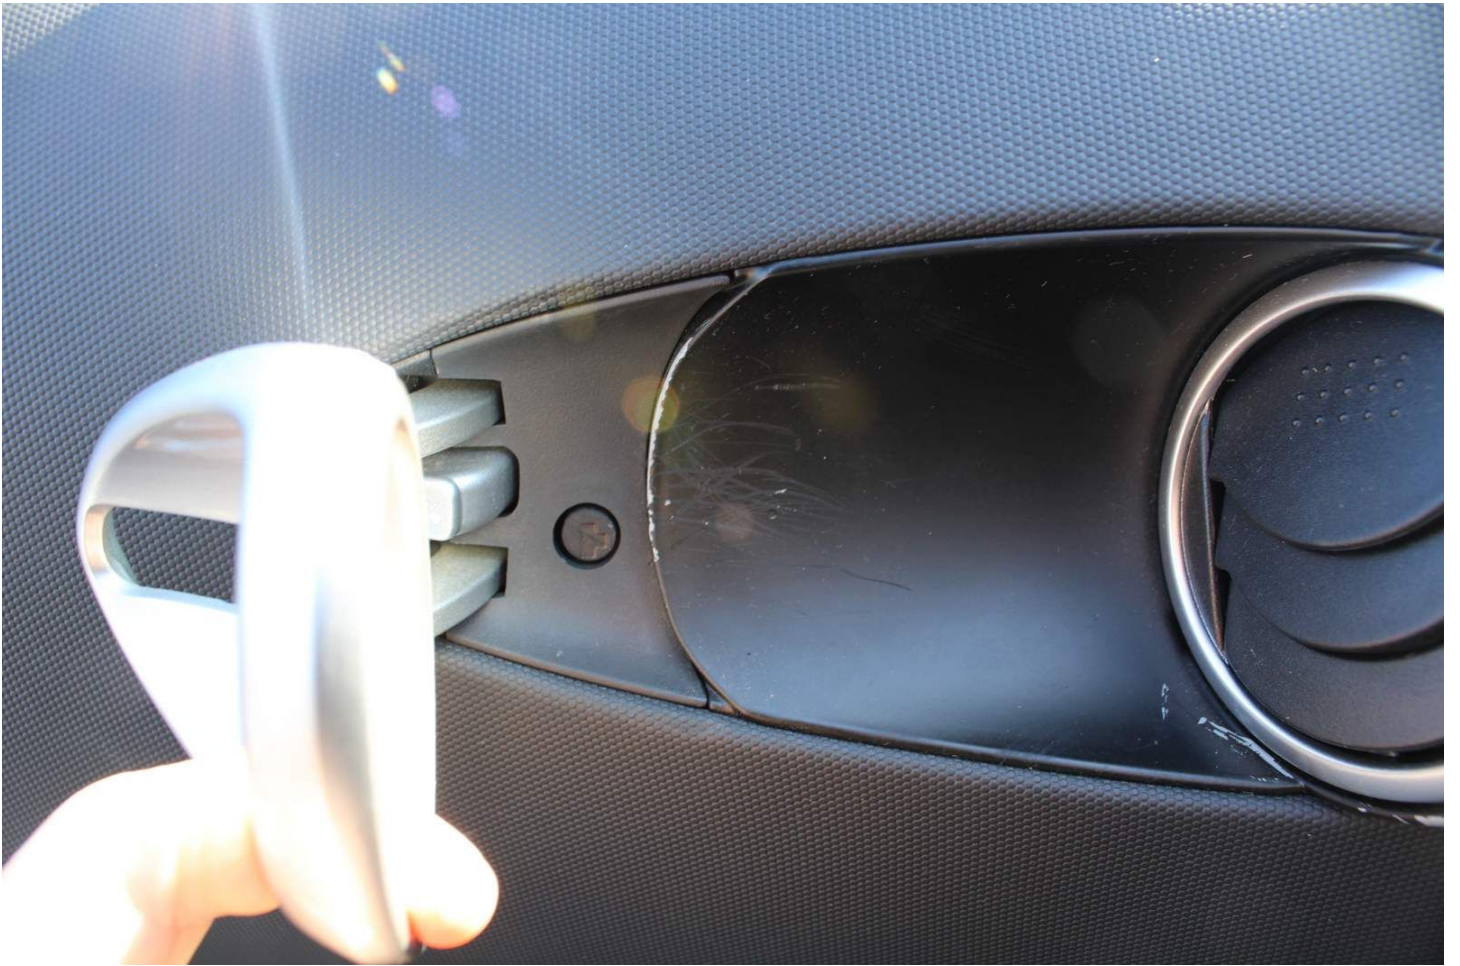
wear and scratches

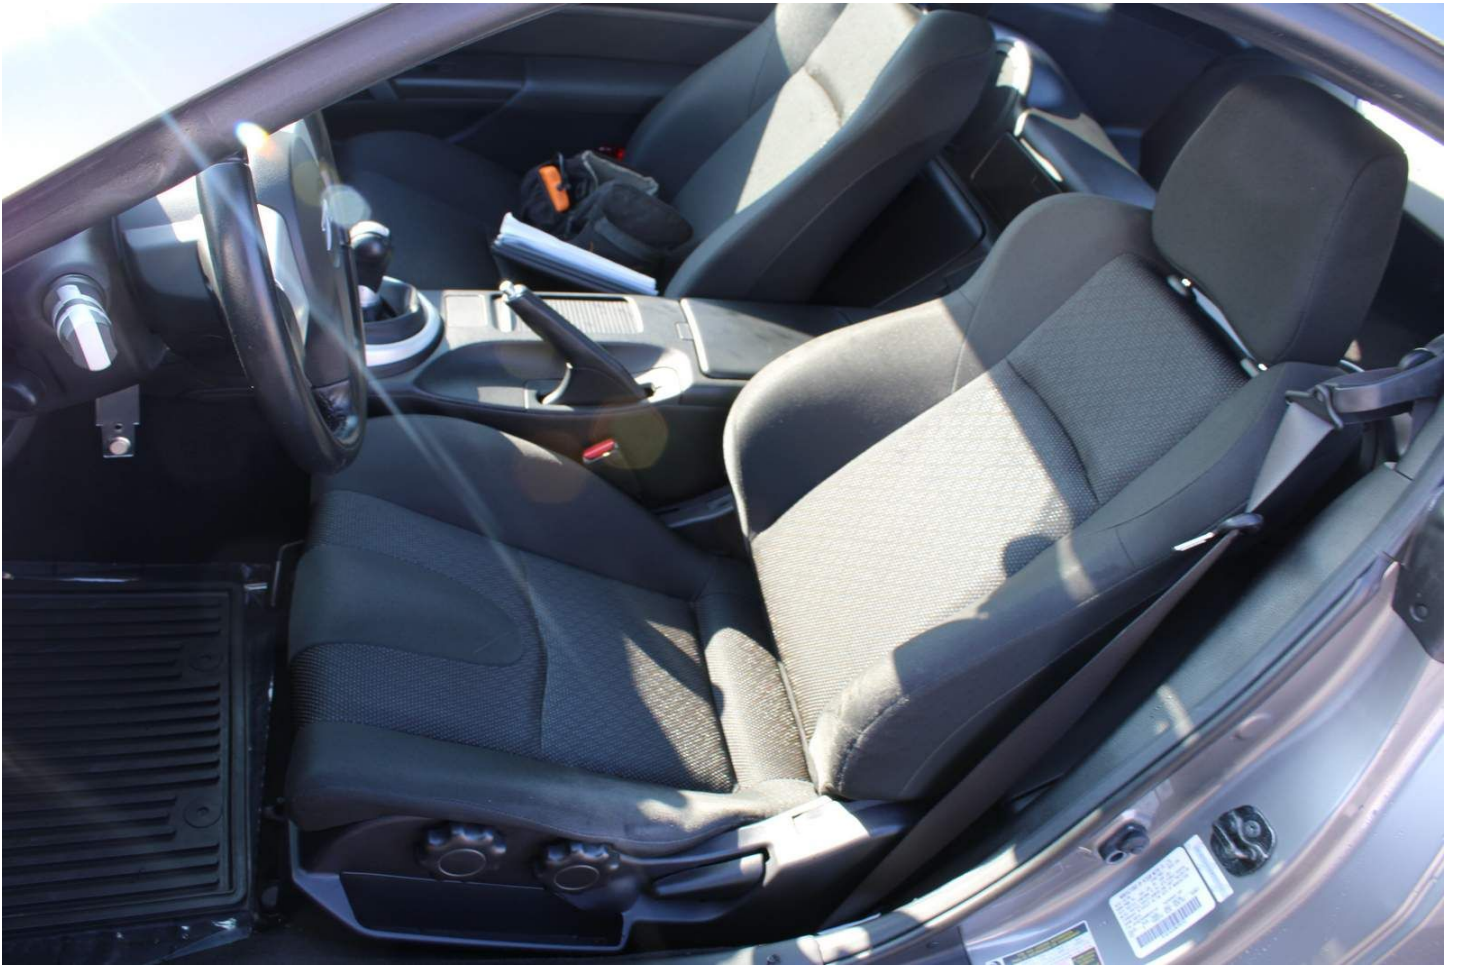
scratches

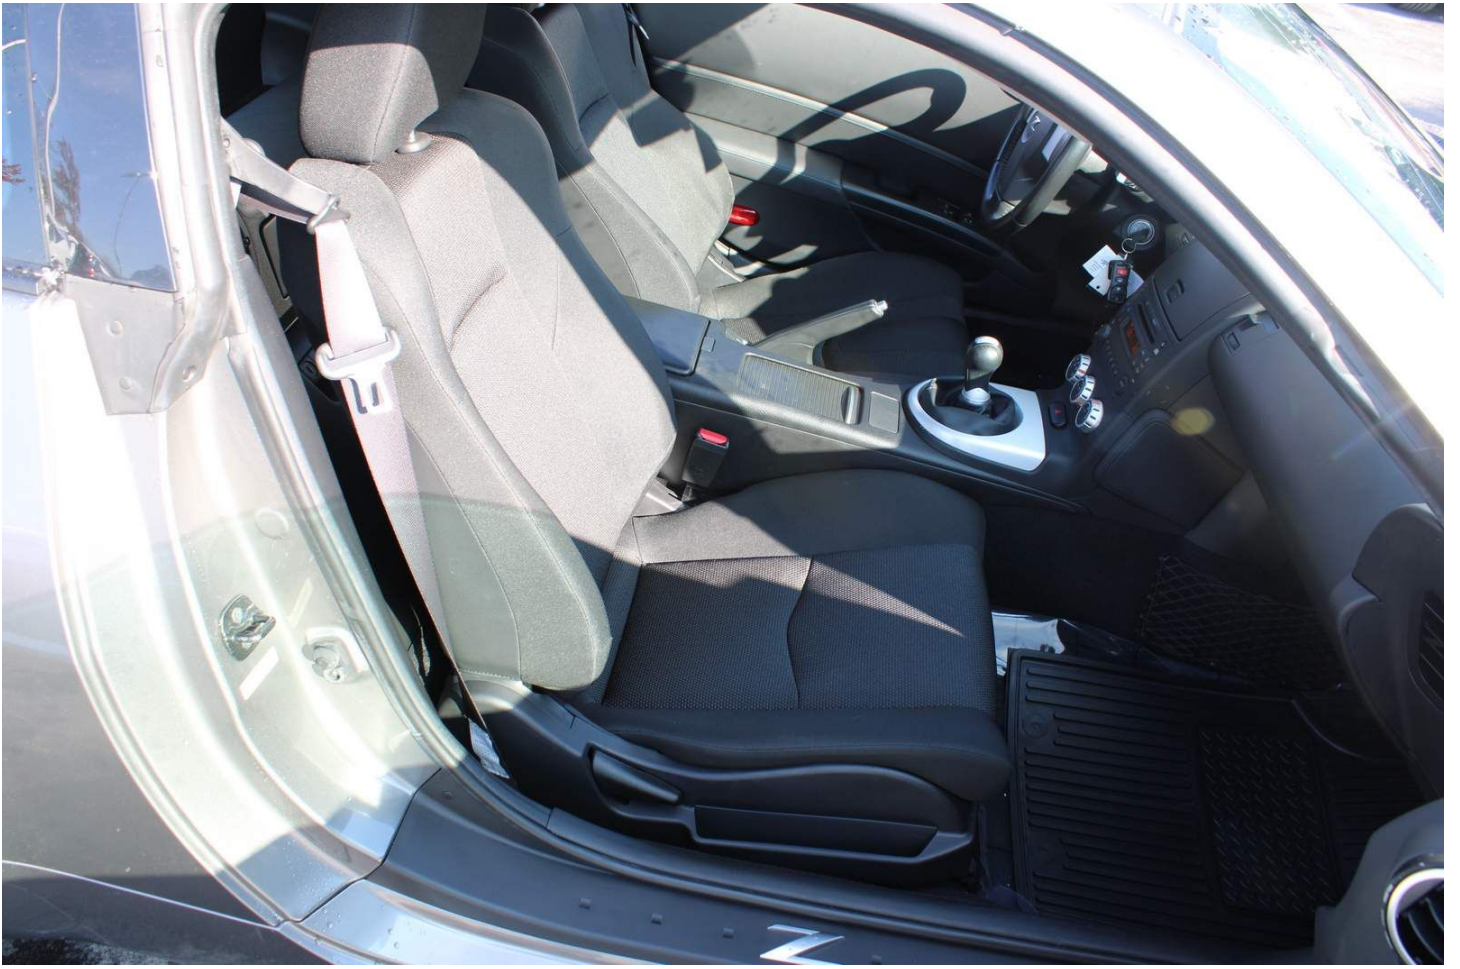
scratches

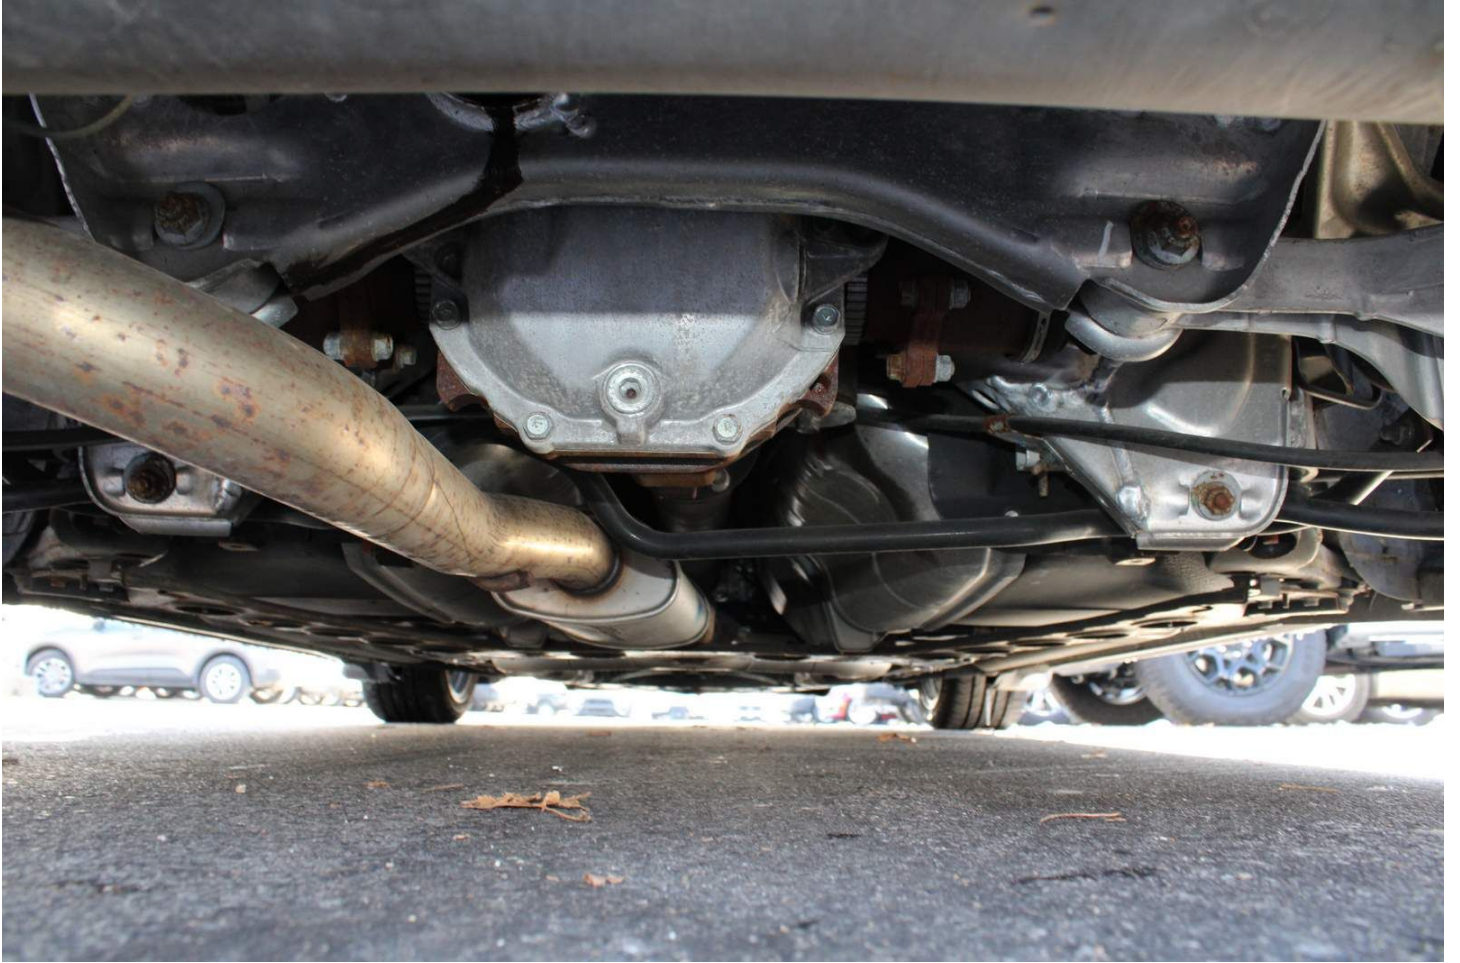
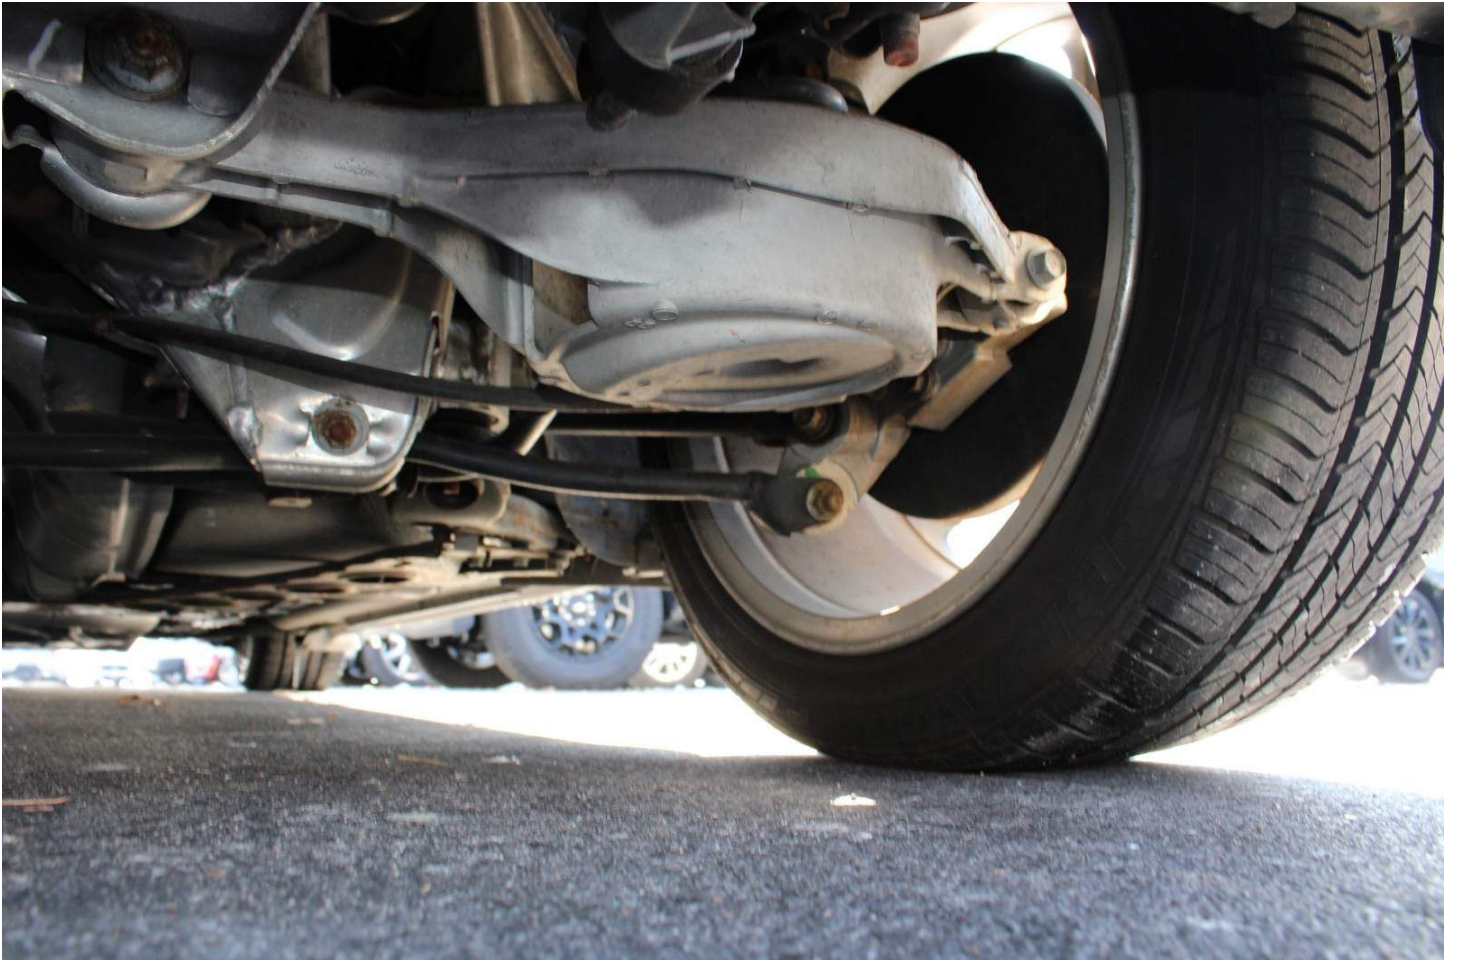
The underside shows areas of surface rust. See pictures.

surface rust

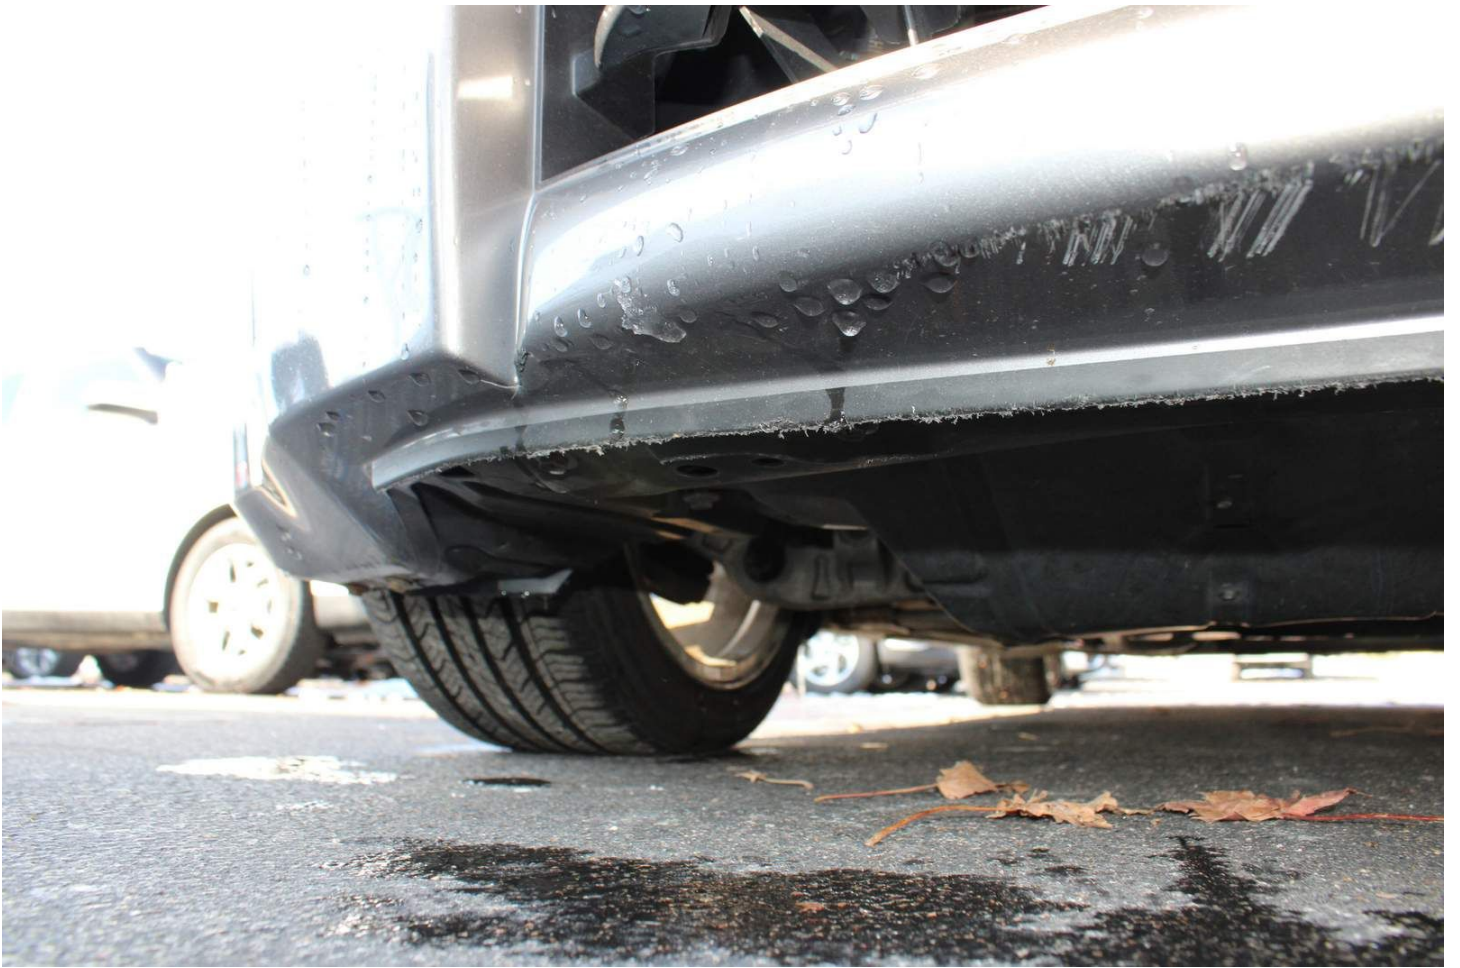
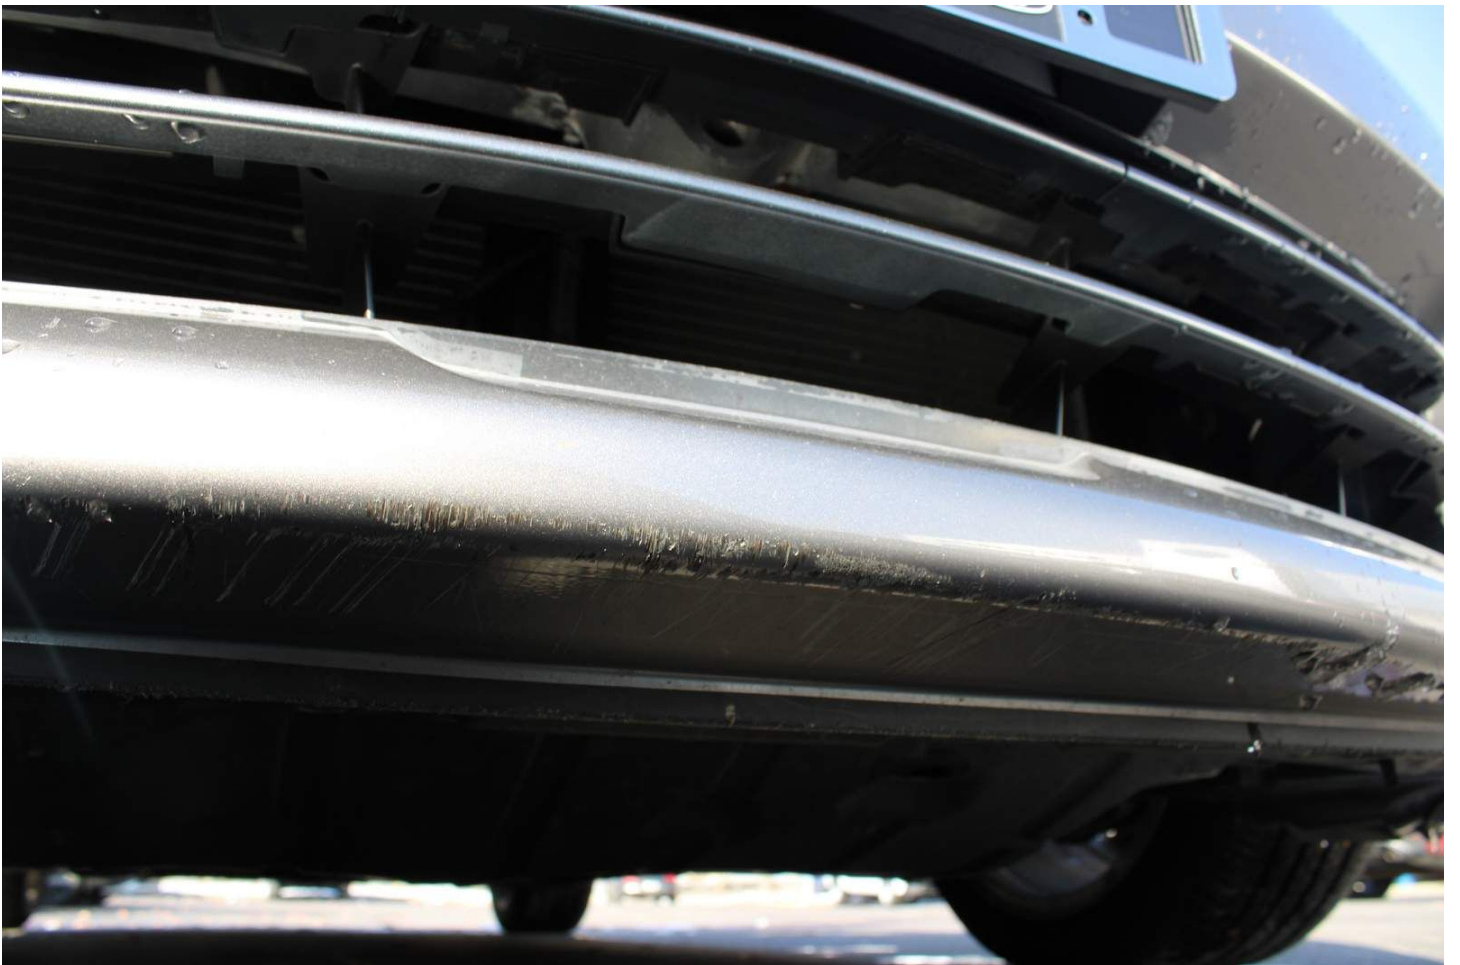
scratches

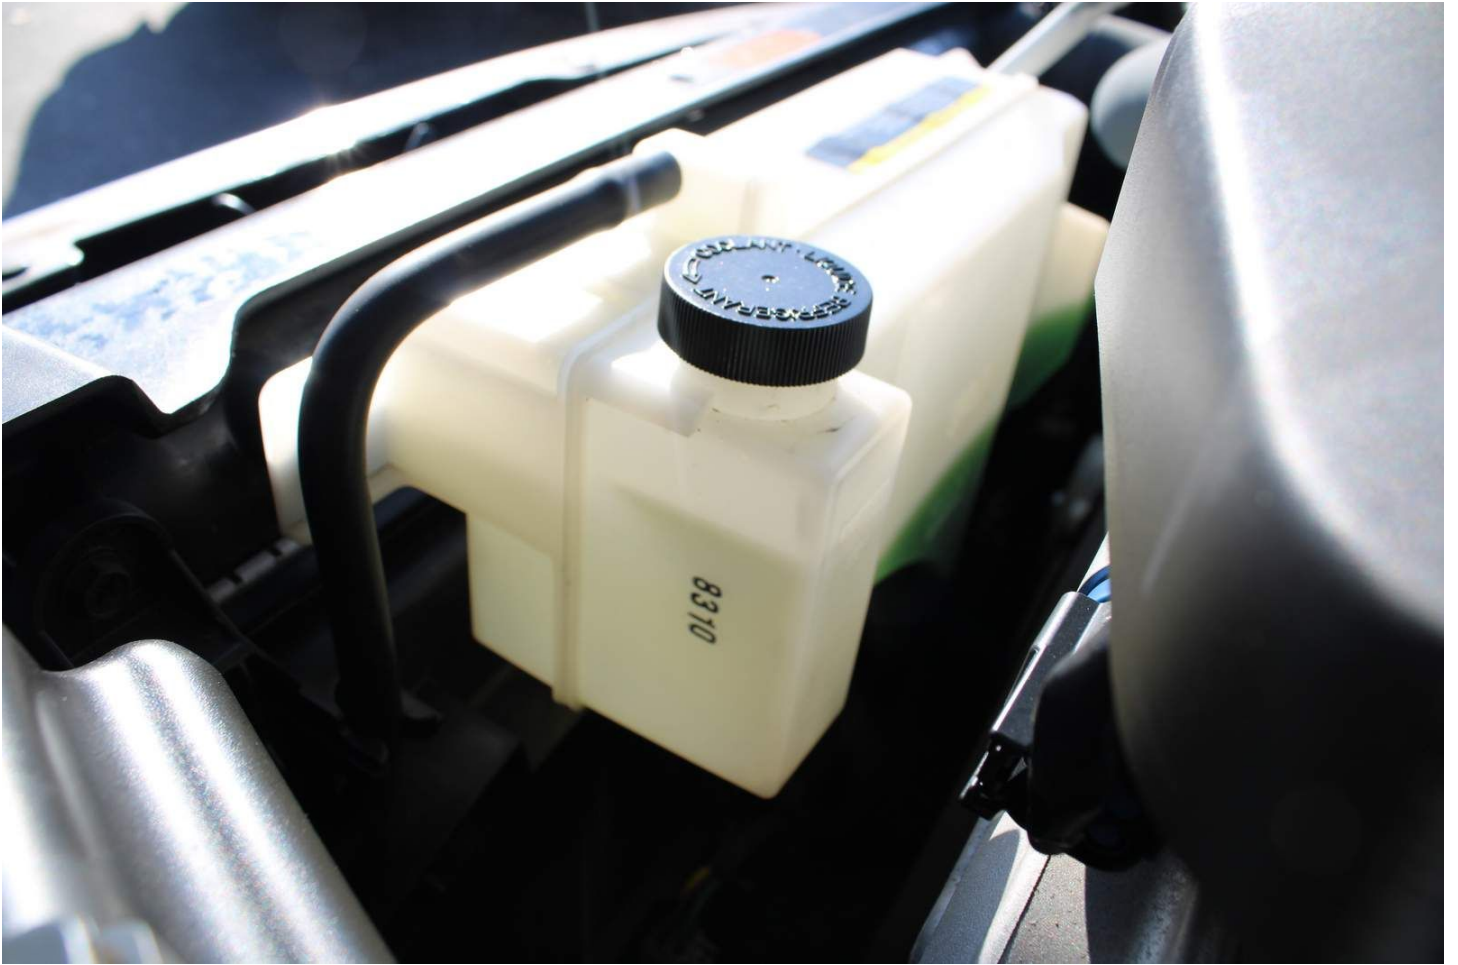
The air filter is dirty and needs to be replaced pic 76.

dirty

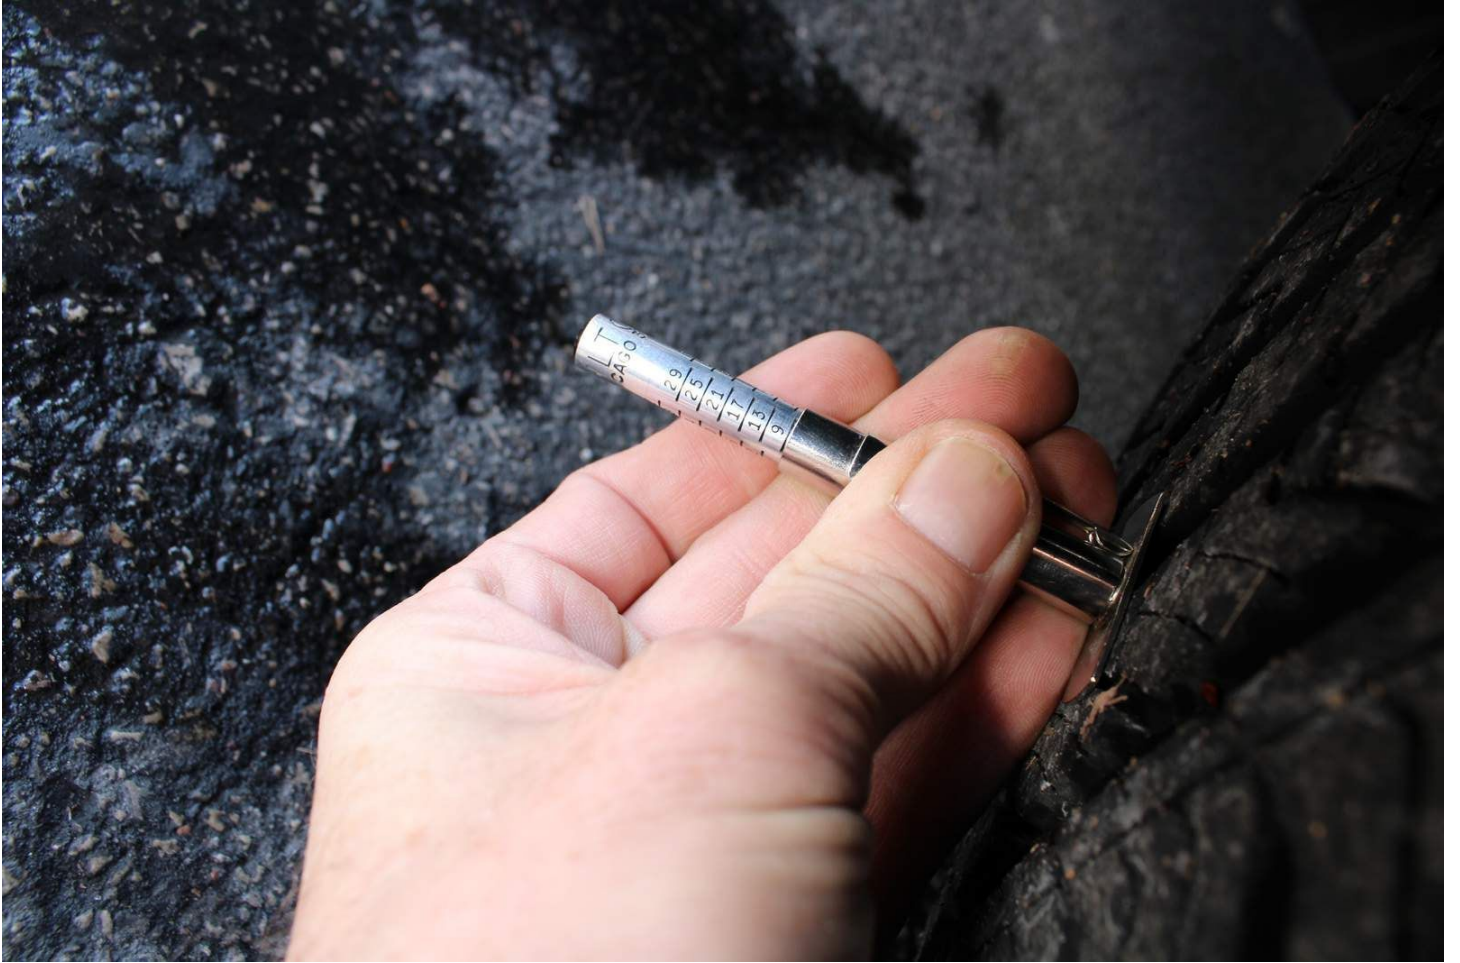
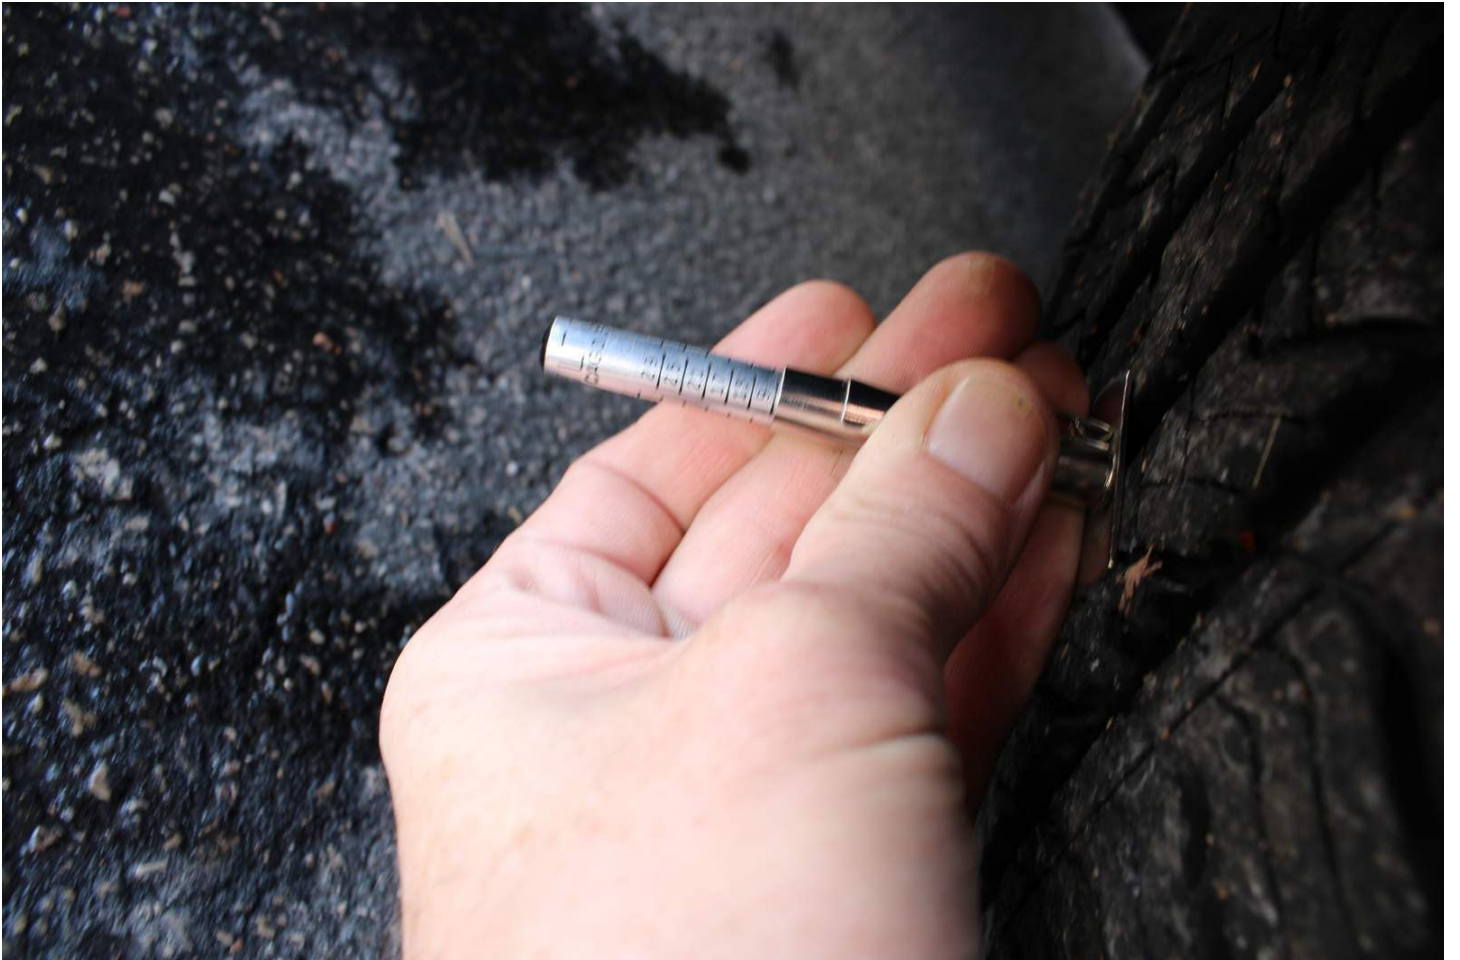
Three of the rims are showing curb rash. Front tire size is 225/45ZR18 while rear tire size is 245/45R18.

curb rash

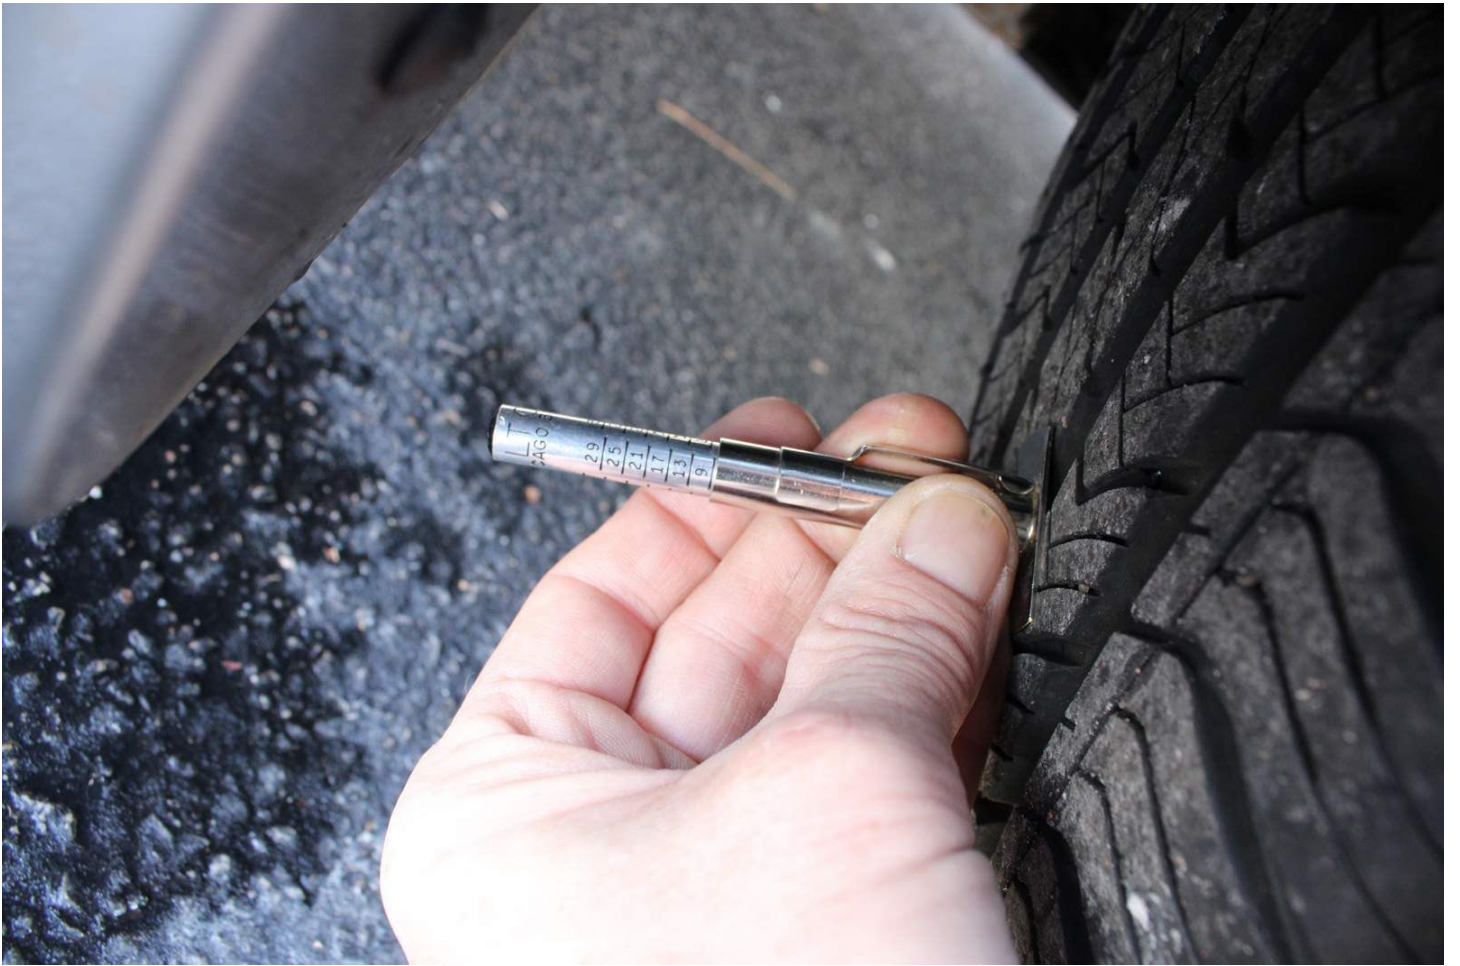
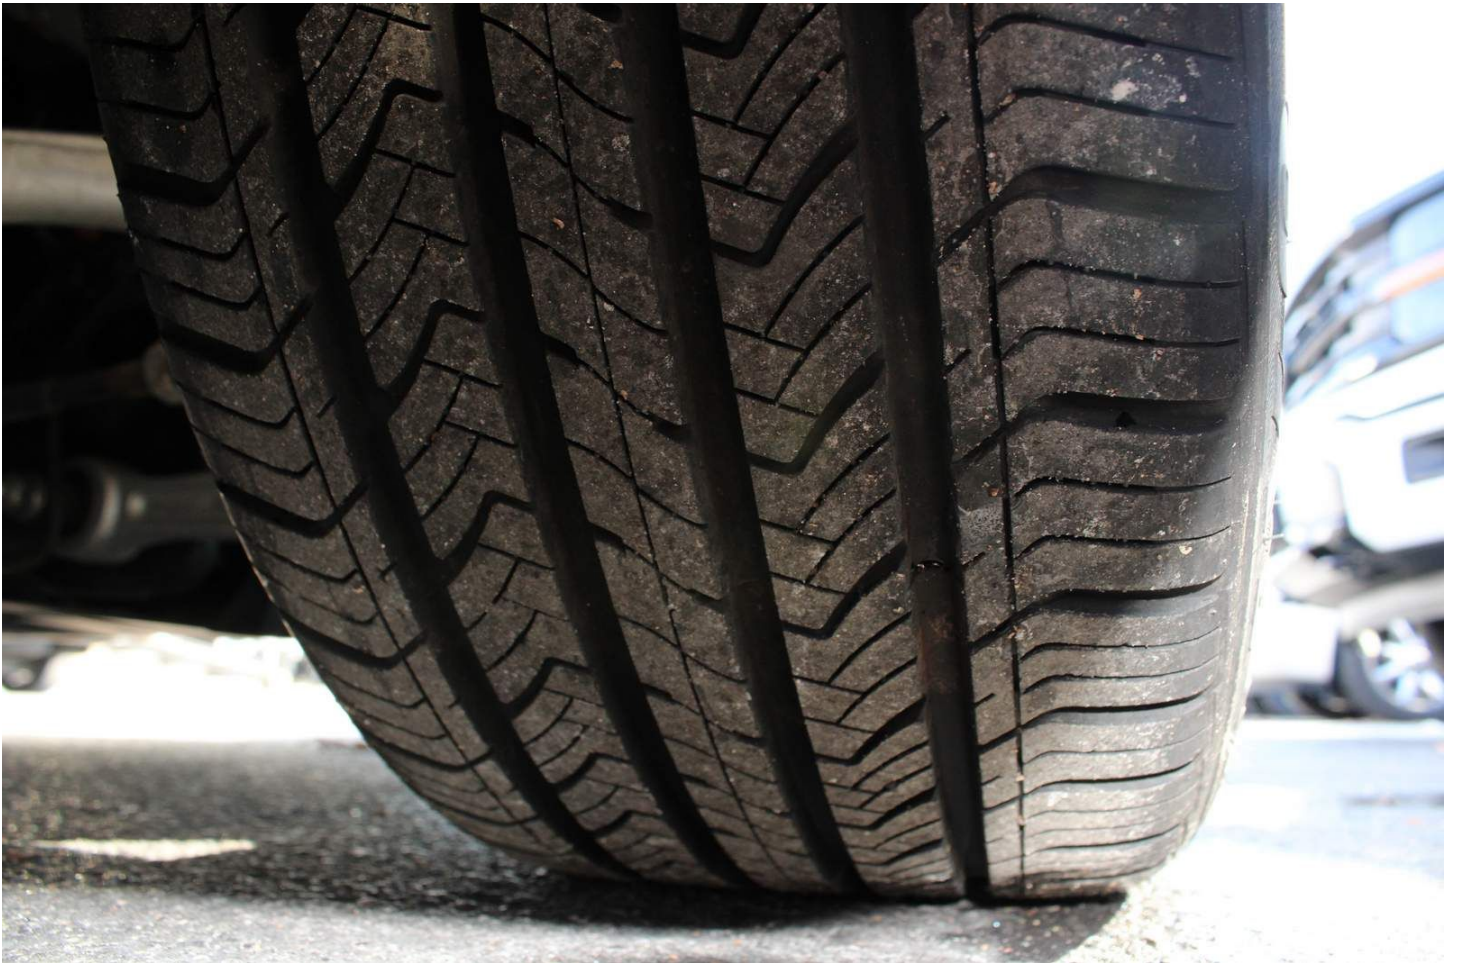
curb rash

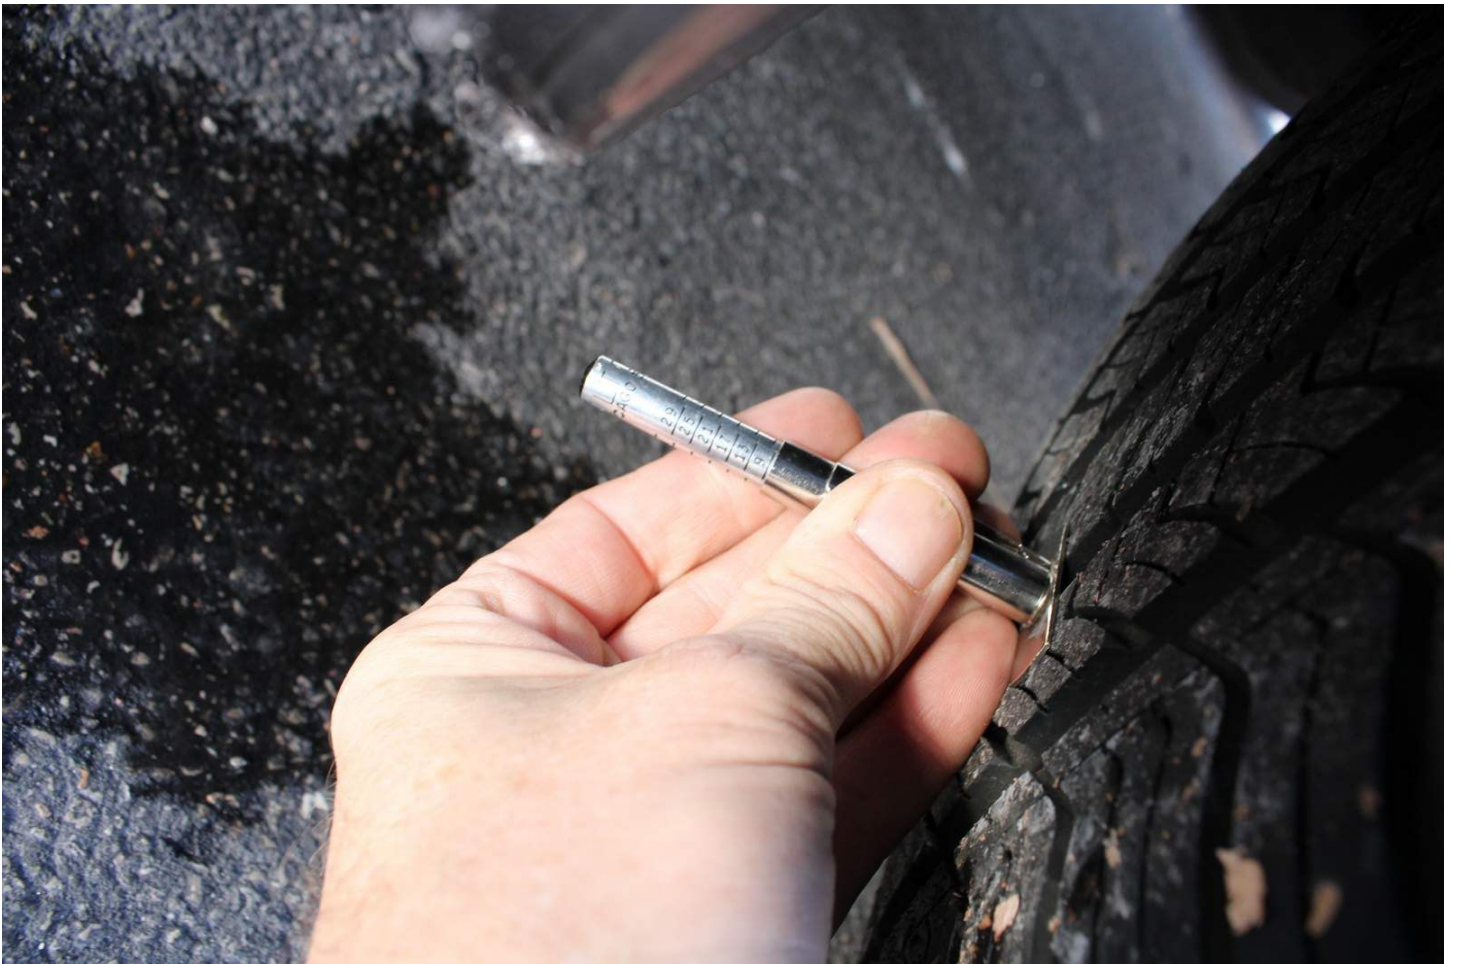
curb rash
